## RANCHO MURIETA COMMUNITY SERVICES DISTRICT

### IMPROVEMENTS COMMITTEE

# MEMORANDUM

Date: December 28, 2016  
To: Improvements Committee  
From: Paul Siebensohn, Director of Field Operations  
Subject: Correspondence from Michael Davis, Robert Hannaford and David Lewis

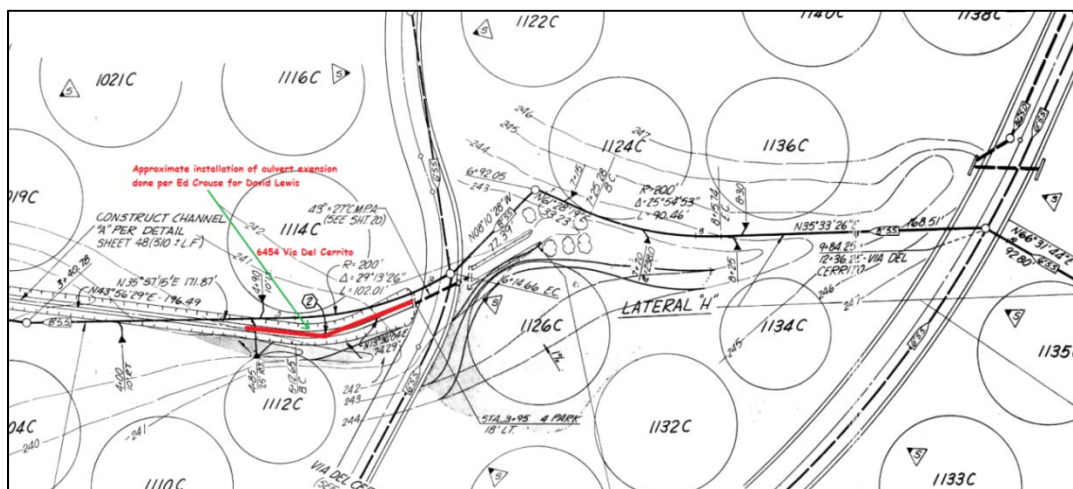
Former General Manager/District Engineer, Edward Crouse, had worked with Mr. Lewis at some point in the past to accommodate Mr. Lewis's concern with potential erosion from the drainage flow channel that ran adjacent to the south east side of his lot. This resulted in a project where the District worked with Mr. Lewis to extend a pipe from the existing culvert alongside his property to satisfy him for a request to do some landscaping in his front yard and channel drainage away from his home. Ed, as the District Engineer, sized the pipe and directed former Utility Supervisor Rob McLeod to install it with the assistance of Carillo Enterprises in the summer of 2008. Ed said it was done in agreement with David Lewis, which Mr. Lewis had confirmed with me in previous personal meetings. The project resulted in the installation of approximately 100' of 24" soil tight high density polyethylene pipe from the existing headwall between lots 1114 & 1112, as depicted in the drawing below.

After the pipe was installed and backfilled over by the District, Mr. Lewis had subsequently landscaped the area extending outside his lot including planting of trees and a DG path.

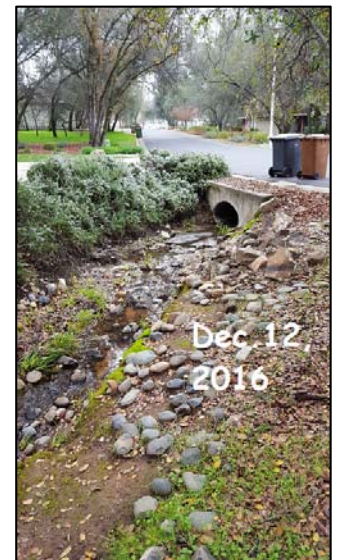
After the first event I have staff check this culvert, and sometimes myself as shown in photo to the right, before each large predicted storm. I had also had staff remove some concrete and rocks that were limiting the flow into the upstream side of the pipe.

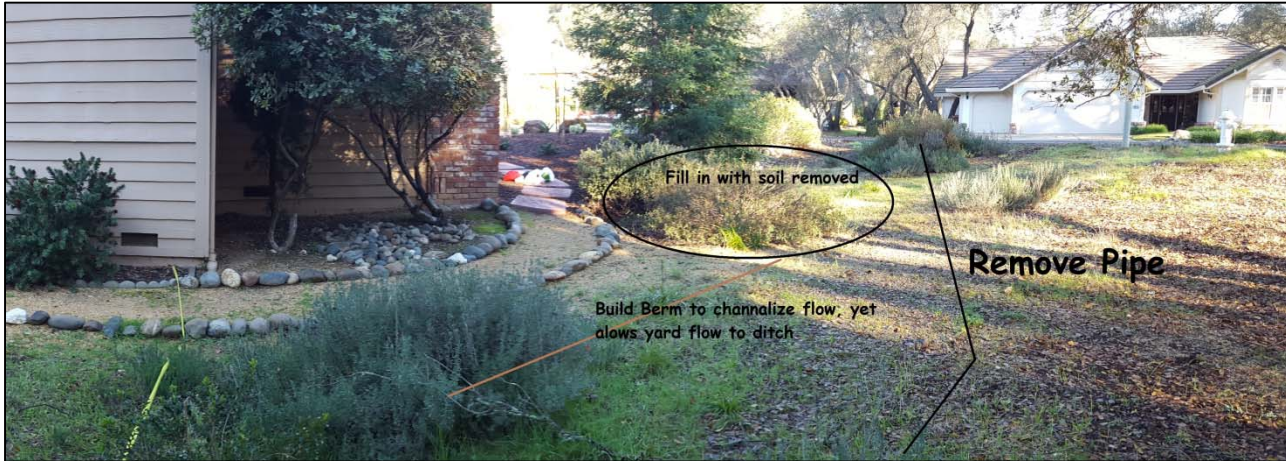
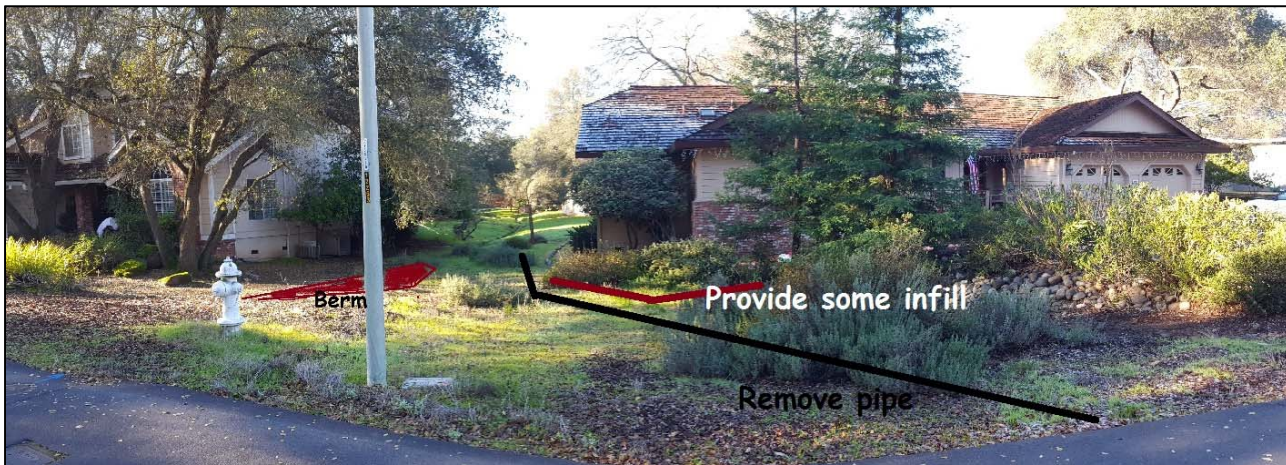
A general idea of what District could do is shown below:

I believe the simplest solution moving forward is to proceed as I had previously recommended to Mr. Lewis of lot 1114, however issued back the residents of the letter as follows:

The District will be removing the drainage pipe that was installed alongside your home. The former District engineer had staff install the pipe adjacent to your property to remedy previous concerns of lot 1114 along the drainage channel. Removing the pipe extension will put the drainage back to as it was originally designed. As we have discussed with lot 1114, any improvements or obstructions that were placed over the top of the pipe will be removed and discarded. As previously discussed some of the soil removed from the pipe cover may be used to fill the low spot of the front yard of lot 1114 as well as to provide a berm for lot 1112. Lot 1114 may install a block wall along it should they choose to as long as it does not obstruct flow. If any improvements are outside your lot, please contact the RMA Architectural Review before proceeding.

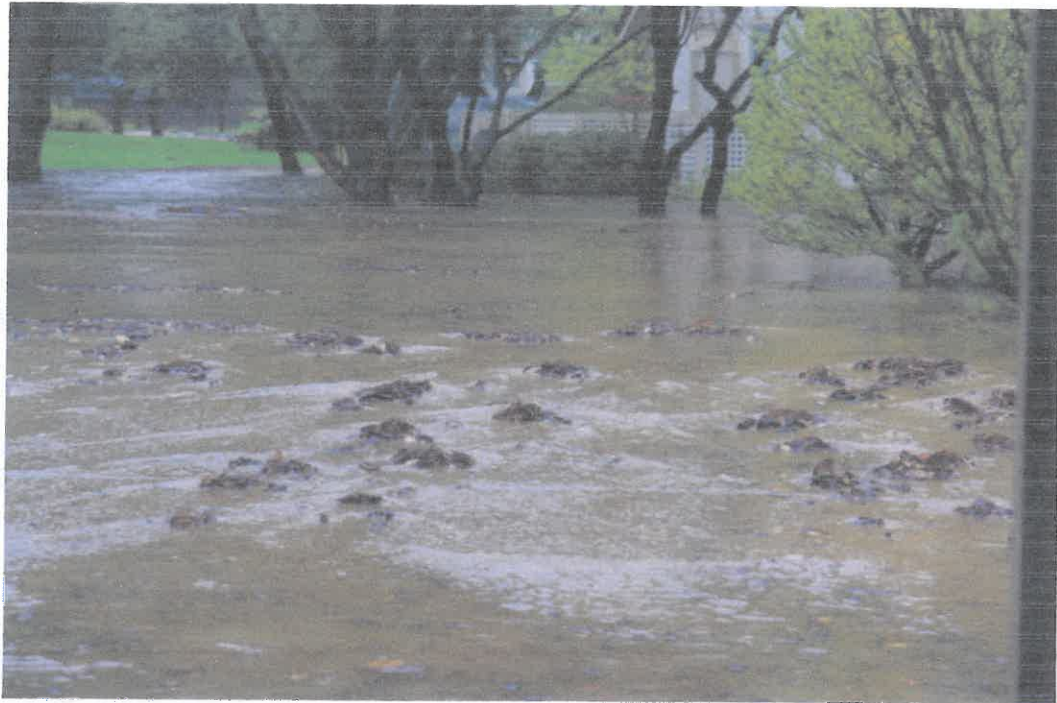
One example of the drainage channel's overflows is shown above. This picture is actually of the street and the front yards and driveways of the houses on opposite sides of the street. You can see the flood covers the street, driveways and has entered the garages of the homes on both sides of the street. The drainage channel enters from between the two oaks at the left and runs along the side of the house in the picture and then flows (or should flow) into a pipe under the street that can no longer be seen because of the consistent overflow problems the channel bottleneck causes. This picture was taken from inside of one of the flooded garages.

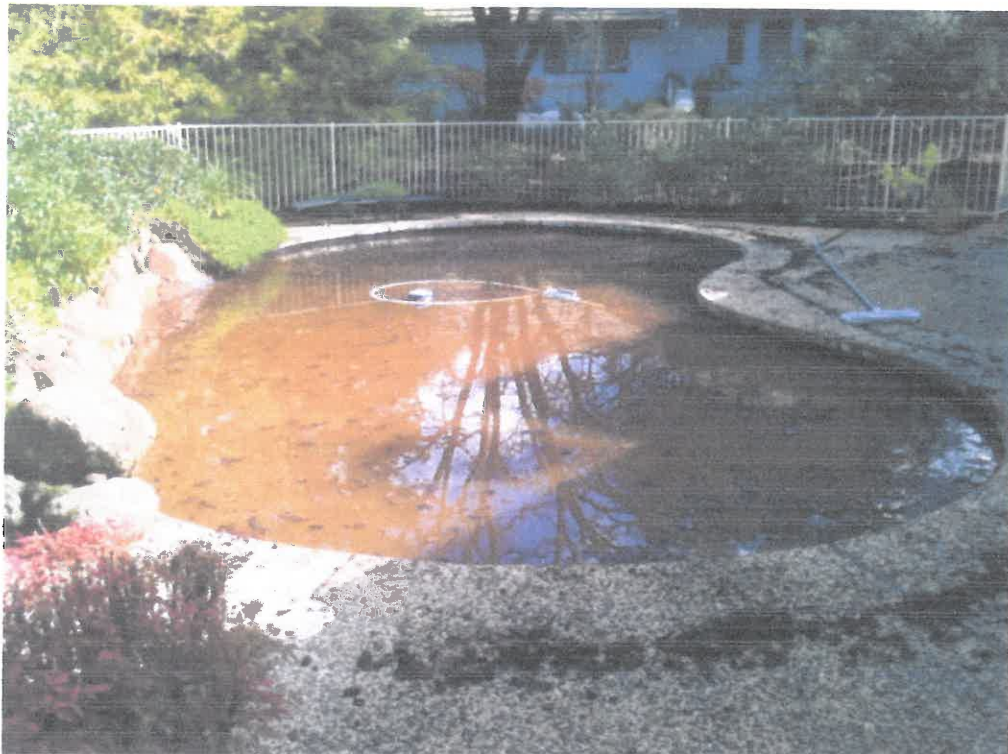
You can see the aftermath of one of the channel overflows that filled this pool with mud.

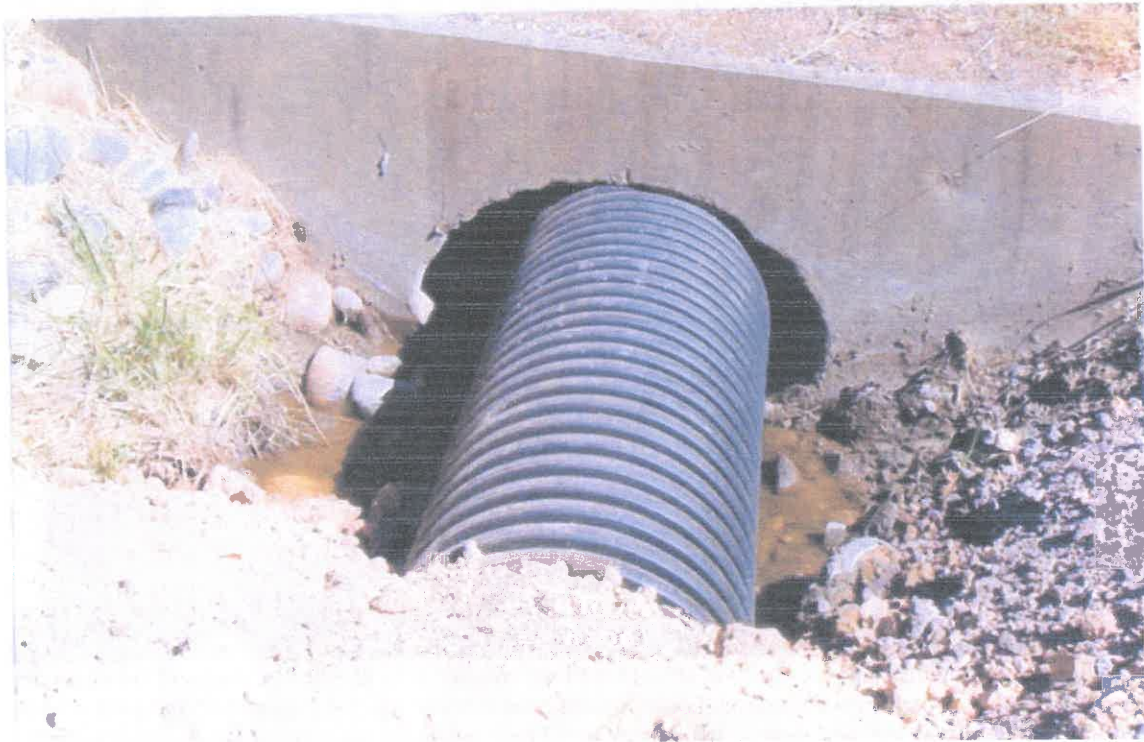
Here you can see the extension pipe being installed by CSD at Via Del Cerrito, Park 4. As you can see it is restrictive and only aggravates an already bad situation. The improper design of the channel at Park 4 already had overflow problems caused by inadequate channel design at this bottleneck point.
