RANCHO MURIETA COMMUNITY SERVICES DISTRICT

MEMORANDUM

Date: December 30, 2021
To: Improvements Committee
From: Michael Fritschi, P.E. - Director of Operations
Subject: Monthly Utilities Department Updates

Date: December 29, 2021
To: Improvements Committee
From: Michael Fritschi, P.E. - Director of Operations
Subject: Lift Station Vulnerability

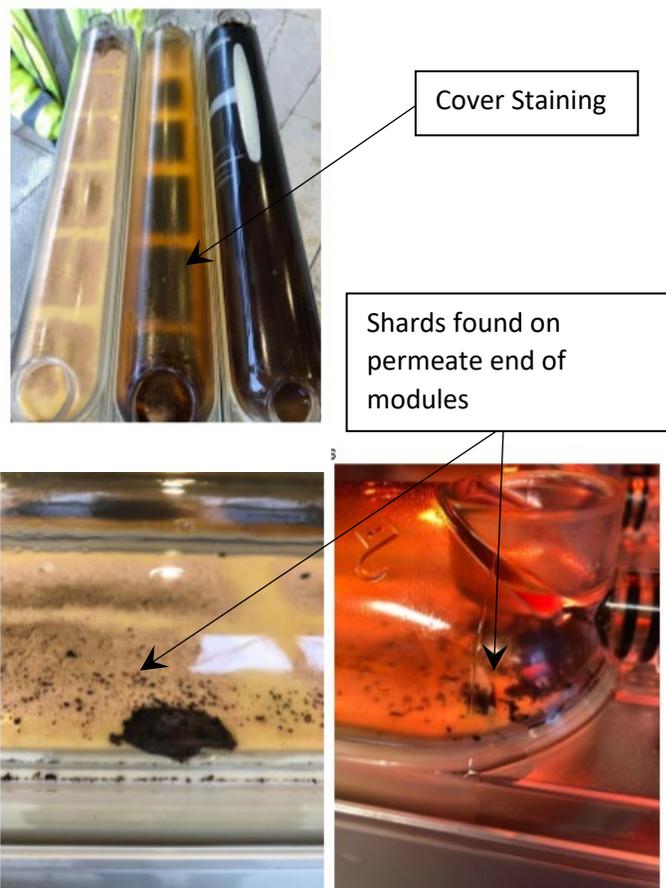
Membranes (Plant 1) -*Some of the Plant 1 membranes are requiring extensive repairs. This has caused significant after-hours required response by operations staff to repair the membranes and keep Plant 1 in operation. It is likely that the membranes are approaching the end of their useful life (7-10 years). According to the manufacturer, the repairs are not UV-curing properly due to the buildup of potassium permanganate staining on the membrane covers blocking the UV-curing process. Plant staff will be increasing the chemical membrane cleaning regiment in an effort to prevent the staining.*

Update: The increase in chemical membrane cleaning has been effective in keeping the transmembrane pressure (TMP) down and Log Removal Value (LRV) up (more efficient operation). As previously mentioned, the back-pulse pumps will be pulled and re-coated to prevent the coating chips (shards) from further shearing membranes. Plant staff will still need to deal with the manganese or potassium permanganate that is causing the staining on the cover, which inhibits UV curing repair.

The manganese is typically a summer problem. Plant staff will also need to get with the manufacturer to update the cost of membrane replacement for future capital improvements budgeting as the membranes, while still performing well are getting to the end of their useful life.

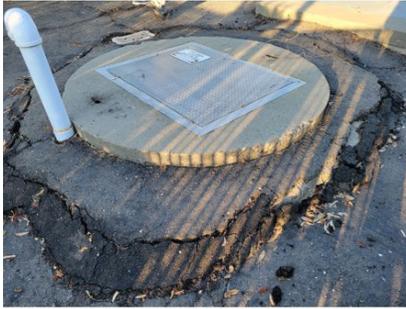
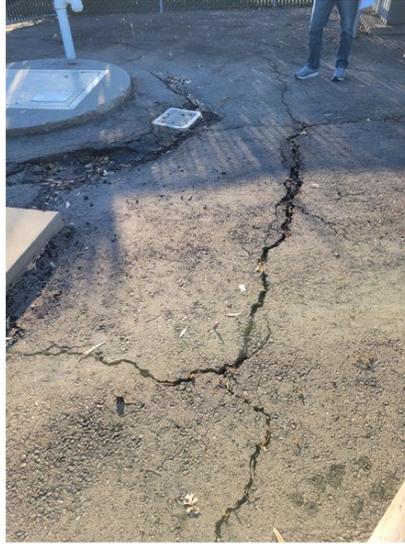
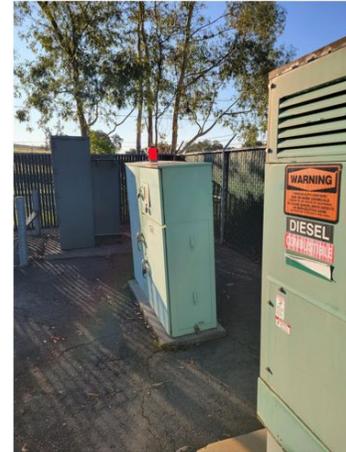
Green - This lift station is located at the end of Bent Grass Ct.

Issues: The area surrounding the lift station and the lift station control panel appears to have experienced some settlement and may need to be corrected. *See pictures below.*

Prognosis: If the settling continues the discharge piping and electrical conduits could become compromised.

Proposed Solution: Evaluate the soil around the station and attempt to determine if additional settlement may occur and if the actual wetwell has settled. Excavate around the discharge and intake piping and determine if there appears to be strain on the pipes. Examine pipe joints and re-install pipe as needed. Re-set the control panel and potentially remove asphalt and re-compact the material around the wet well and re-pave the section.
