# CIA Ditch

## Operations & Maintenance Manual

Rancho Murieta Community Services District  
15160 Jackson Road  
Rancho Murieta, CA 9683

Updated March 2020

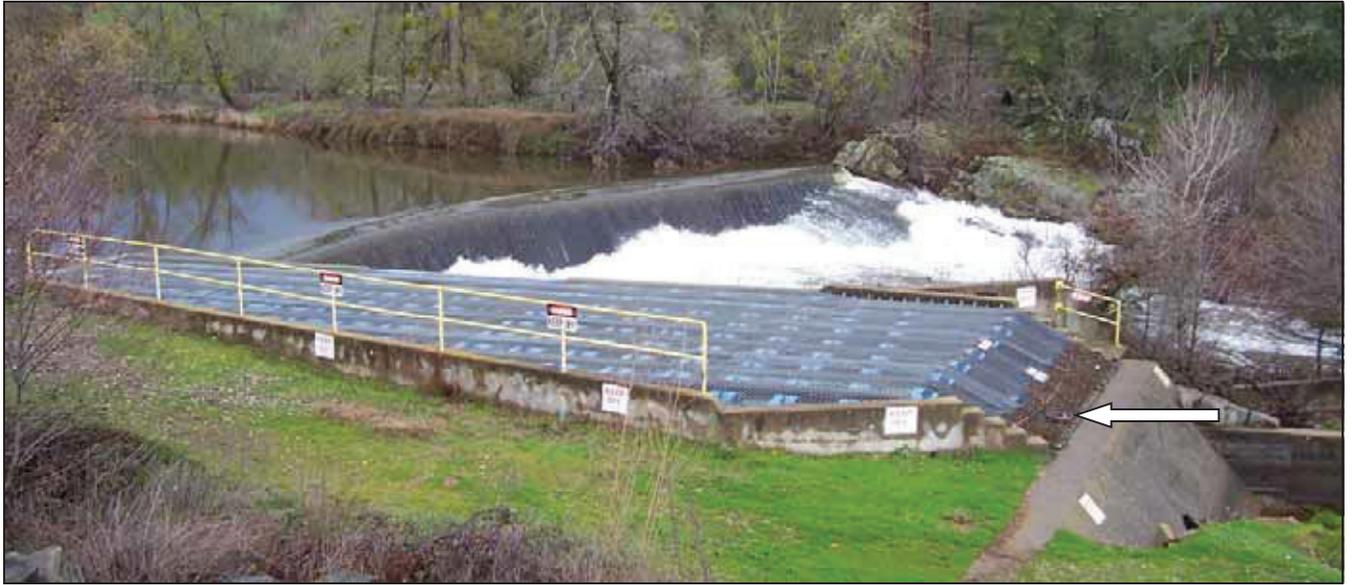
Granlees Diversion Structure with arrow showing Point 1

There are several points of diversion in to and out of the CIA ditch. The main point of Diversion in to the CIA ditch occurs at the Granlees Diversion structure, noted by [Point 1](#) in figure 1. Water in the Cosumnes River behind the Granlees North side diversion dam flows through a bar screen into the Granlees diversion structure. [Point 1](#) is the hand operated valve that releases water from the Granlees diversion structure into the CIA ditch. It is kept locked with a short piece of chain and a District B-key. When opening this valve be sure to not open it too much so that downstream banks of the ditch do not overflow and wash out. After opening, periodically check downstream to ensure that the flow is not obstructed or too high. Also pay attention to the flow in the Cosumnes River as flow changes will significantly affect the flow into the ditch. Upstream of Granlees dam flow is measured at the USGS & DWR Michigan Bar Gauging station, whose flow can be found on the internet here: <http://cdec.water.ca.gov/cgi-progs/queryF?s=MHB>

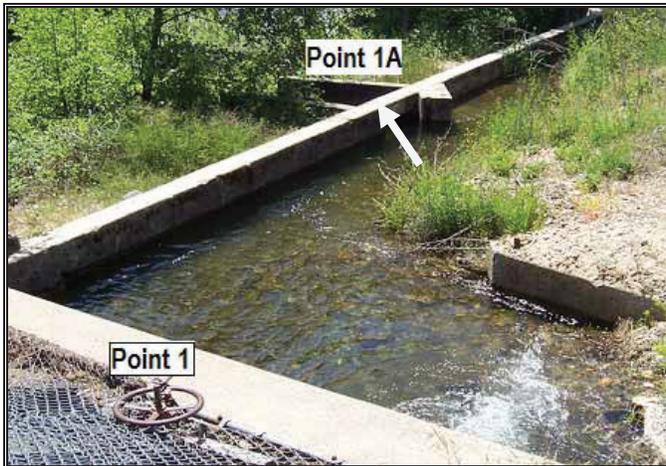
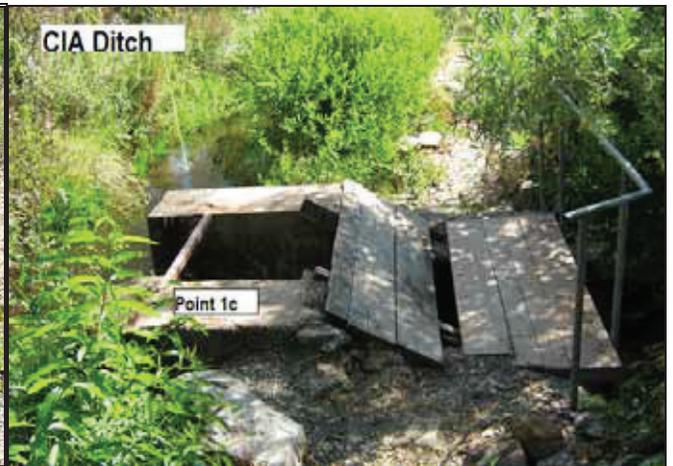
**Point 1a** is an outlet structure containing batter boards which allows the top portion of the ditch to drain back into the River. The batter boards are usually removed during winter months to prevent high river flows from entering the ditch with the potential of washing it out or filling it with debris, mainly sand. **Point 1c** is another ditch outlet structure to release water back into the river to prevent washouts or maintenance. The boards there would not be removed during a normal rainy season. However, if there are substantial rains and rains forecasted, the boards there should be removed. Downstream from 1a is the staff gauge (*shown on right*) which is used to measure the depth of flow in the ditch. This is read daily when the ditch is flowing and recorded on a daily spreadsheet maintained by the Districts Operations staff. Shown below is a bubbler tube which is also used to measure the height of flow in the ditch as it flows over the calibrated weir to convert it to flow, recorded on the chart recorder inside the Granlees pump station.

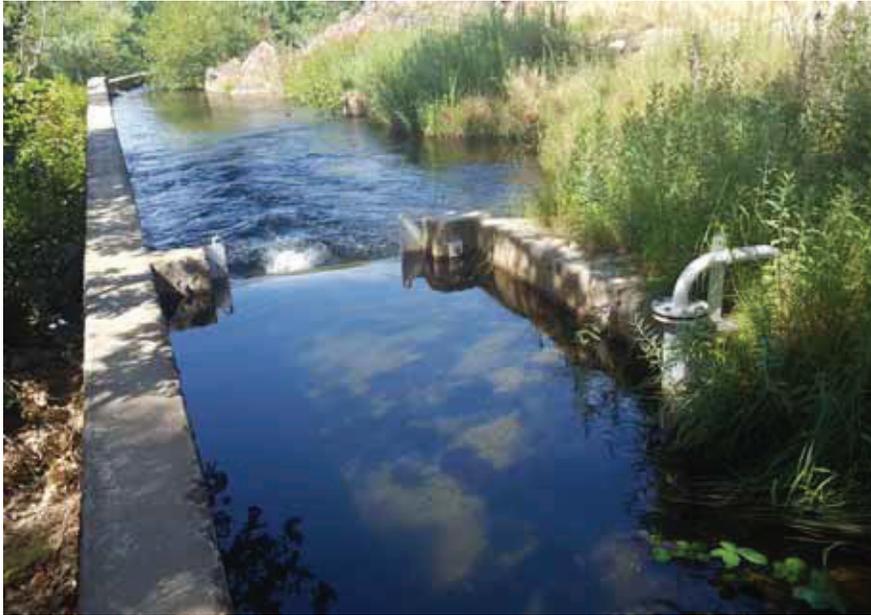
At point 1b is a valve and diversion structure that may be used in times of drought to release water from Clementia into the ditch. A series of valves would need to be opened first.

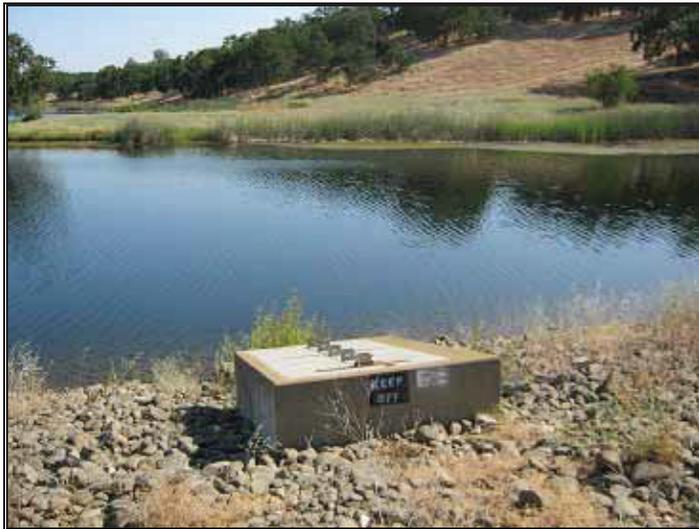
*Valve vault to release water from Clementia*

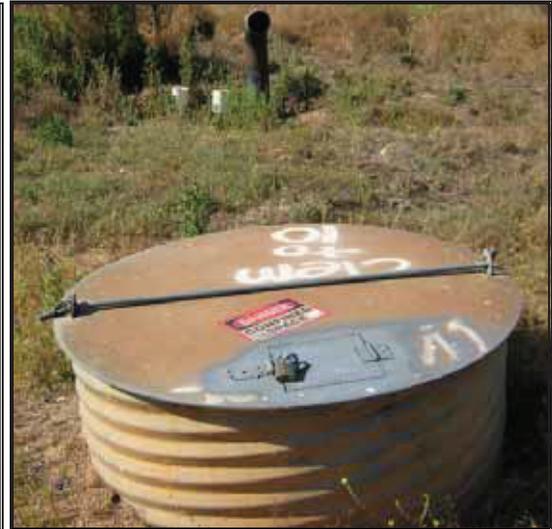
*Flow meter vault from Clementia & valves*

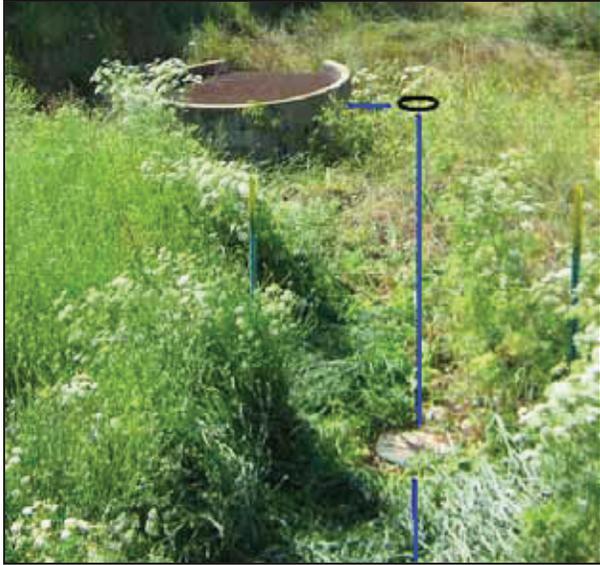
*Valves and Discharge structure at Point 1b*

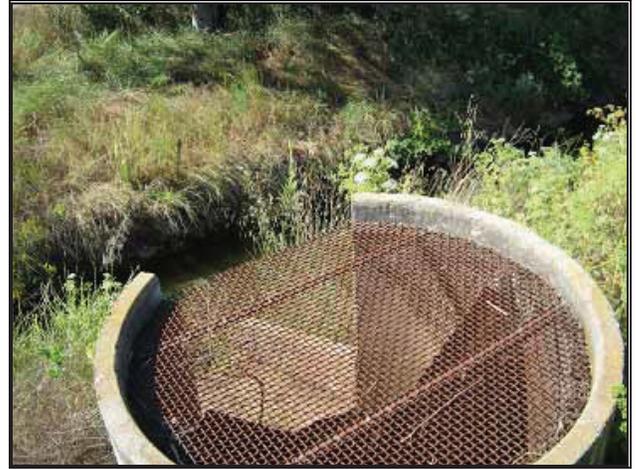
*Discharge structure at Point 1b into CIA ditch*

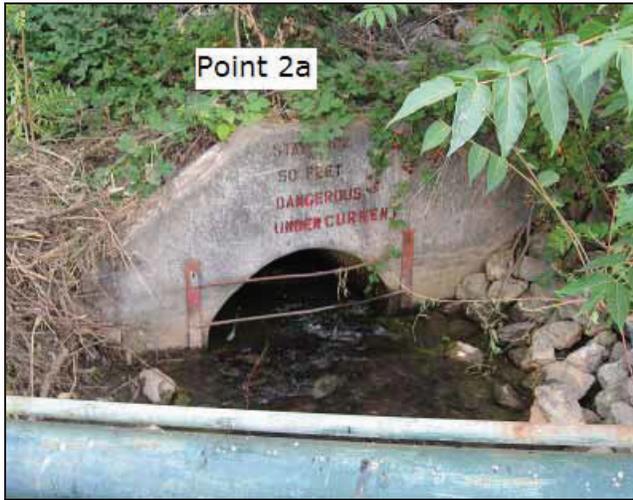
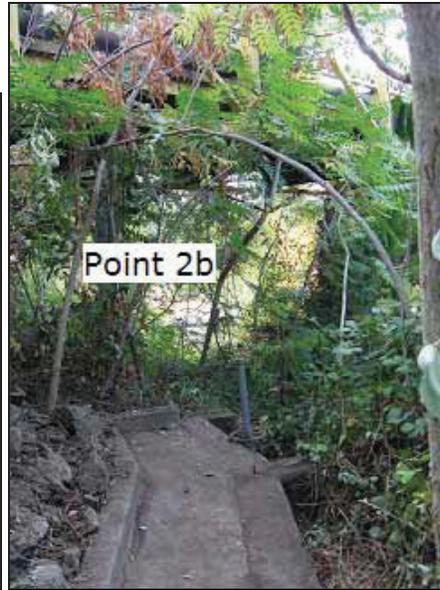
At [point 2a](#) the ditch goes through a bar screen and into a pipe that runs under the Yellow Bridge. This screen needs to be checked periodically to ensure that debris are not backing up the ditch. This is particularly a problem when beavers are present in late summer when the Cosumnes River flow drops. They tend to go up into the ditch at that time and block up the ditch with sticks. If that is left unattended, the ditch could back up, spill over the bank and wash out the embankment.

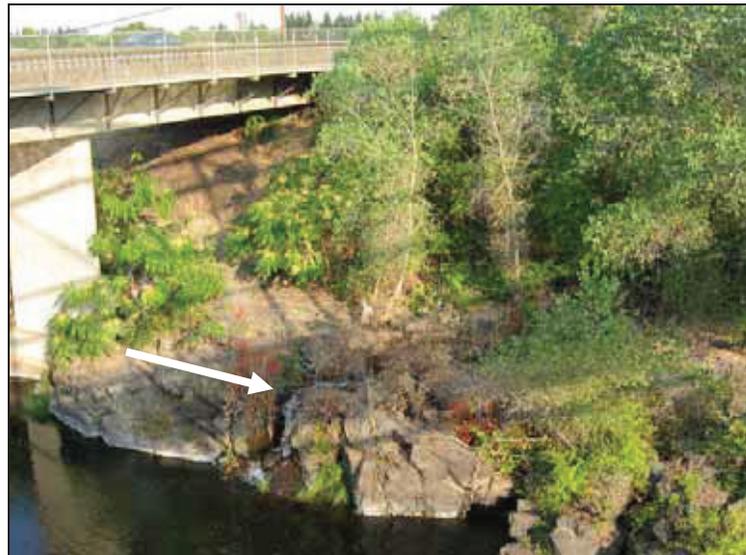
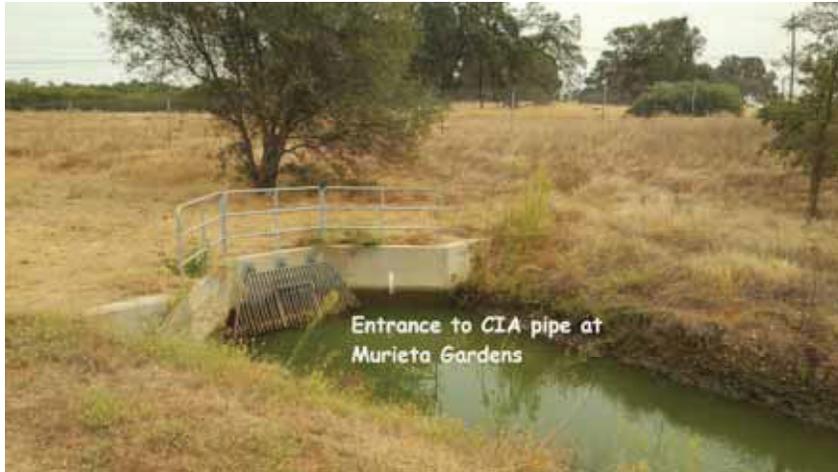
At [point 2b](#) the ditch reemerges in a pipeline past the Yellow Bridge and there is a valve there to release water back into the River. It is used in late season when flows are low in the River to provide water to the downstream ranchers (Schneider & Hutchison ranches, among many more downstream). The ranchers prefer that we run water through the ditch and then release it there, as the river bed between the Granlees Diversion and the Yellow Bridge absorbs a lot more of the water flowing down it. Also, as we may be alternating water to the Anderson Ranch and the riparian ranchers, there is no delay in receiving water by releasing at Point 2b vs flowing down the river or filling up the ditch. Photo below shows water running from Point 2b back into the river between the Yellow Bridge and Jackson Highway Bridge.

This valve was never metered until the District installed one in 2014. It has sustained repeated vandalism and damage and the downstream ranches requested it be removed as the meter restricts flow. Flow back to the river must be estimated when opened until it can be properly metered.

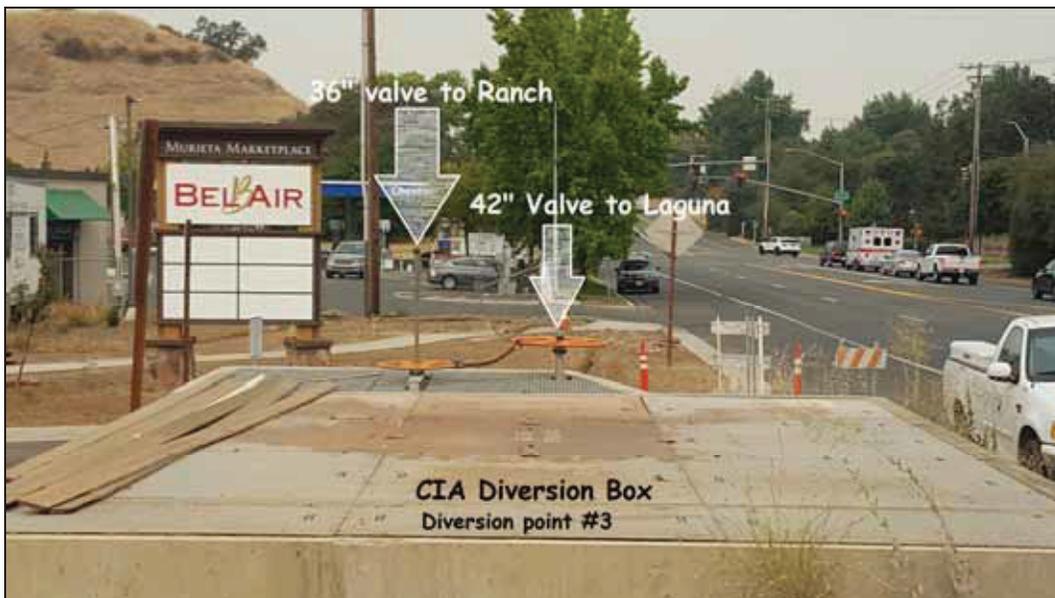
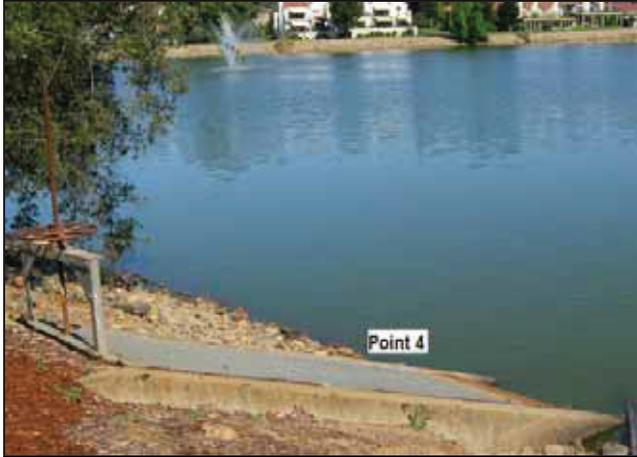
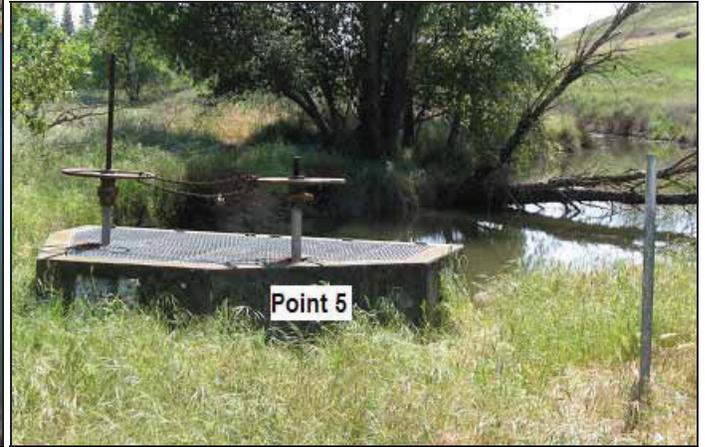
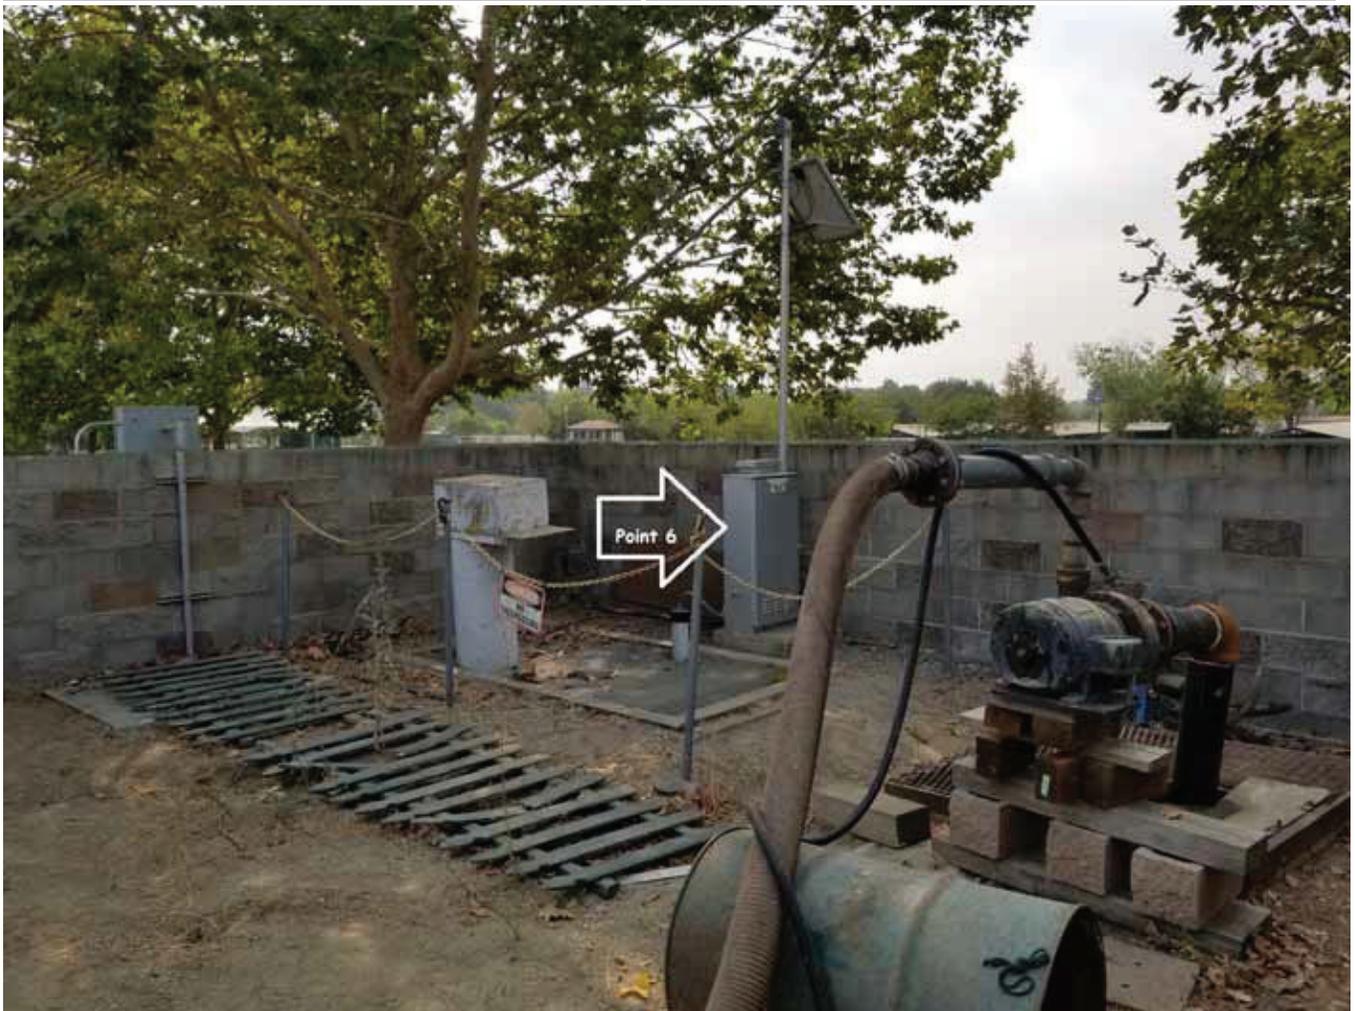
The diversion structure at [Point 3](#) by the Country Store regulates flow into Laguna Joaquin and to the diversion structure at [Point 5](#) behind our Main Lift North sewer pumping station. [Point 4](#) is a valve that is left open all the time. If the valve at [Point 3](#) going to Laguna is left open, [Point 4](#) can back feed the ditch and partially drain Laguna. [Point 5](#) is a valved diversion structure to allow flow back into the CIA ditch behind the District's Main Lift North sewer pumping station, from either Laguna Joaquin or directly upstream on the ditch from [Point 3](#). At Points 3 & 5, experience will guide the ditch tender as how keep flows balanced between flow through Laguna Joaquin and the ditch. During warm weather, the Rancho Murieta Association irrigates areas of common ground with water from Laguna. Therefore, water must be diverted from the ditch into Laguna to satisfy this irrigation demand. Periodically check Laguna's spillway at [Point 4a](#) to make sure water does not drop below 18 inches of freeboard.

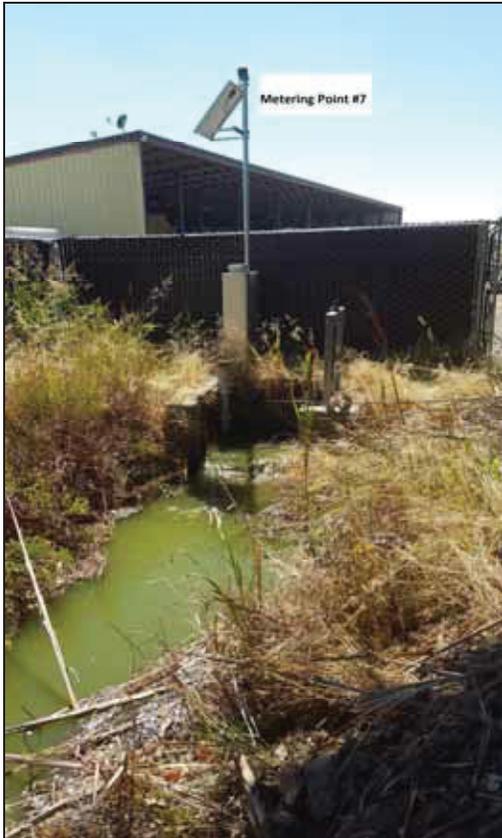
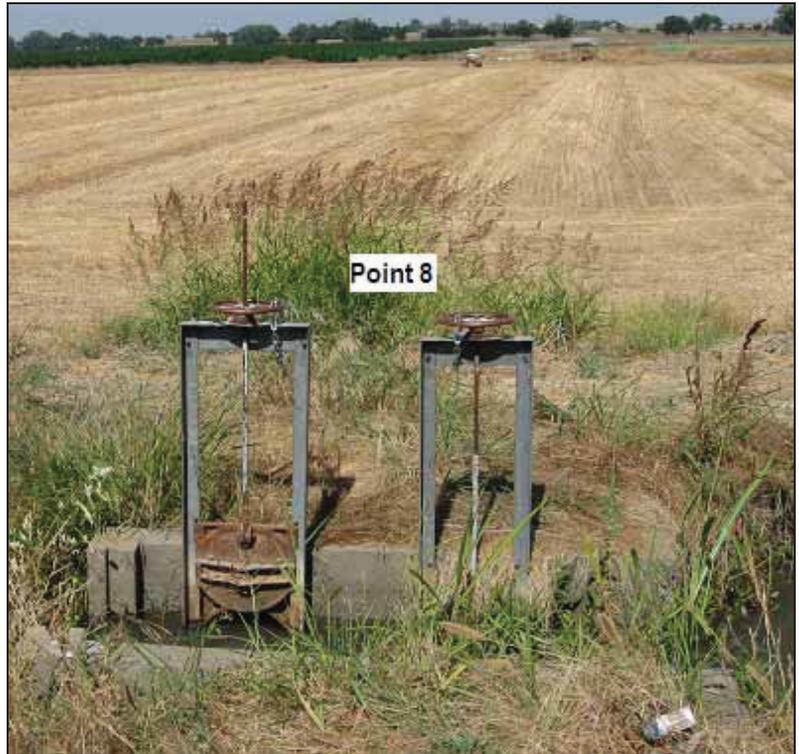
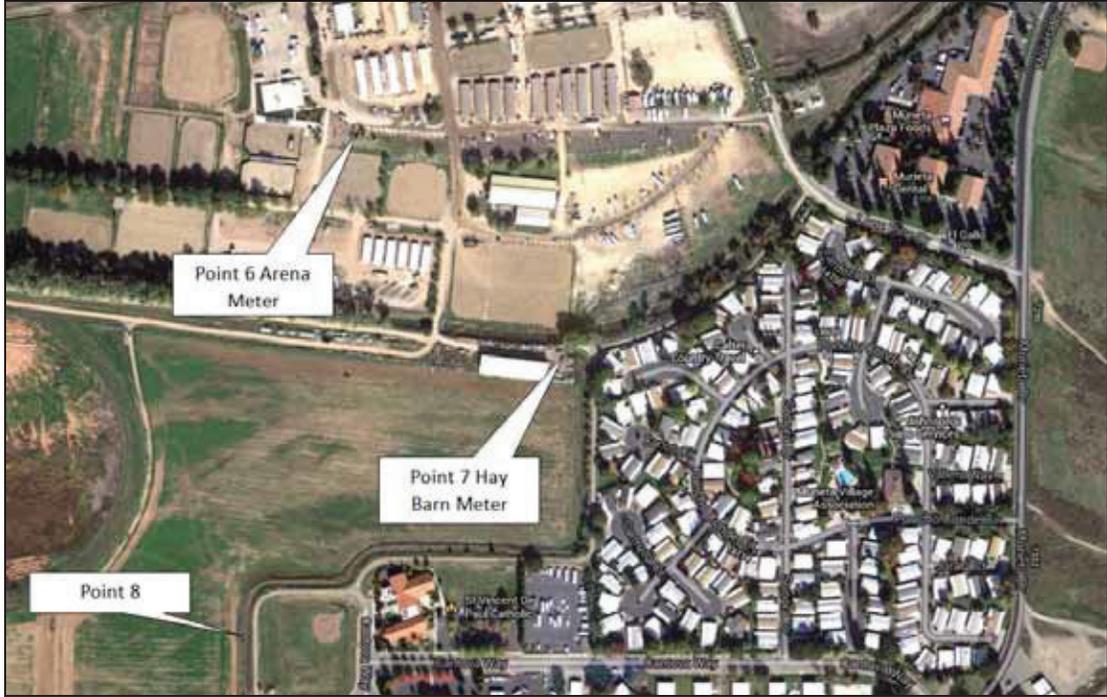
At [Point 6](#) a calibrated ultrasonic device measures the weir overflow at the Murieta Equestrian Center that is used to measure the downstream flow in the ditch. Operations staff checks it daily when in operation. Daily reads from the chart are backed up on the spreadsheet in the Treatment Public network area here: <T:\Treatment Public folder\CIA Ditch>

Point 7 allows water from the ditch to flow to a southern portion of the Anderson Ranch. This point is operated by the Ranch and has a solar powered metering system. Point 8 is also operated by the Anderson Ranch and is used to release ditch water either directly into their field next to the valve, or to another diversion point further east on their ranch.

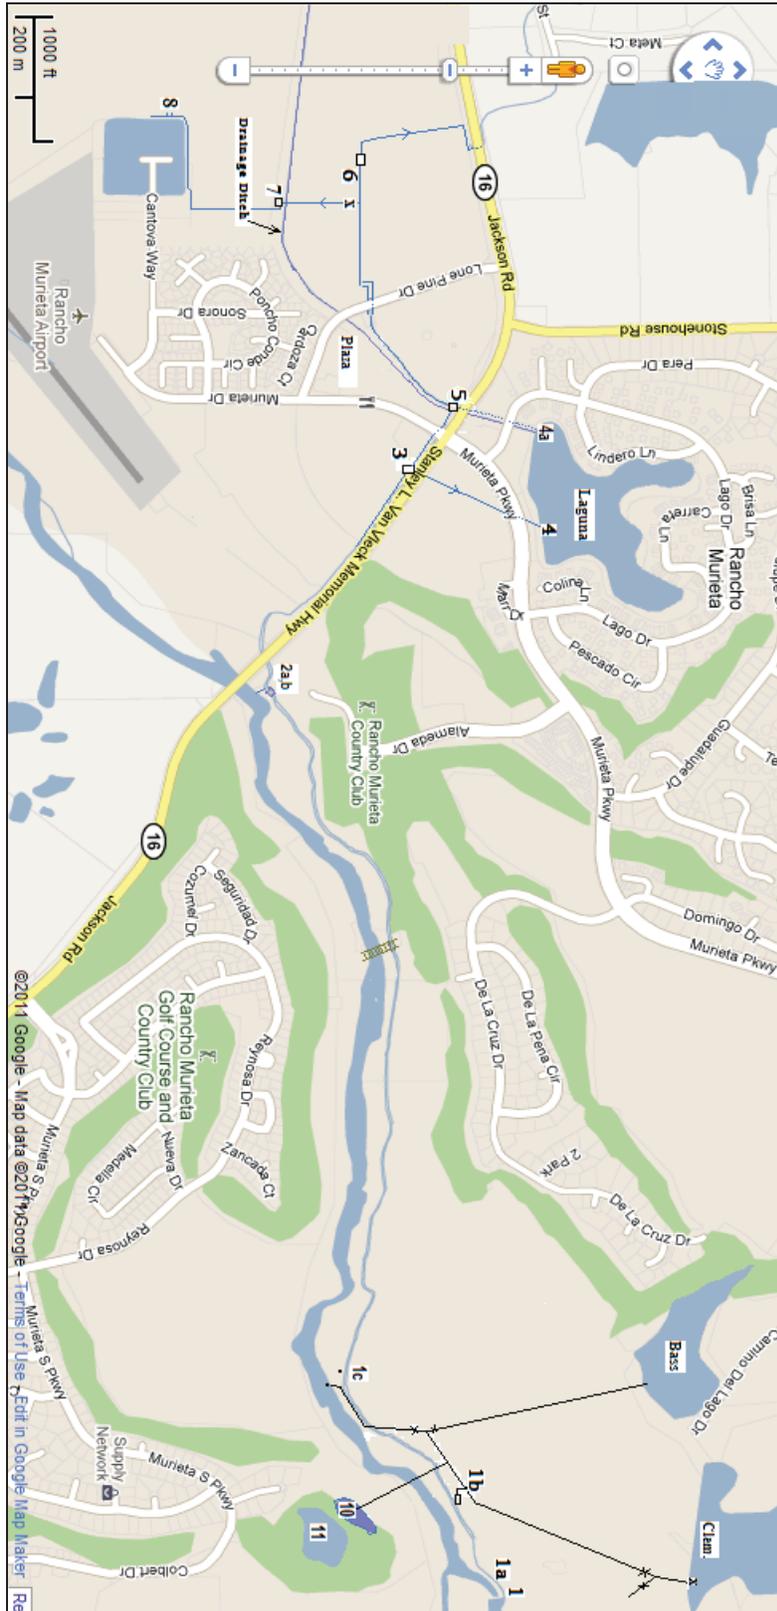
The points of diversion to and from the CIA Ditch are numbered in Figure 1 below.

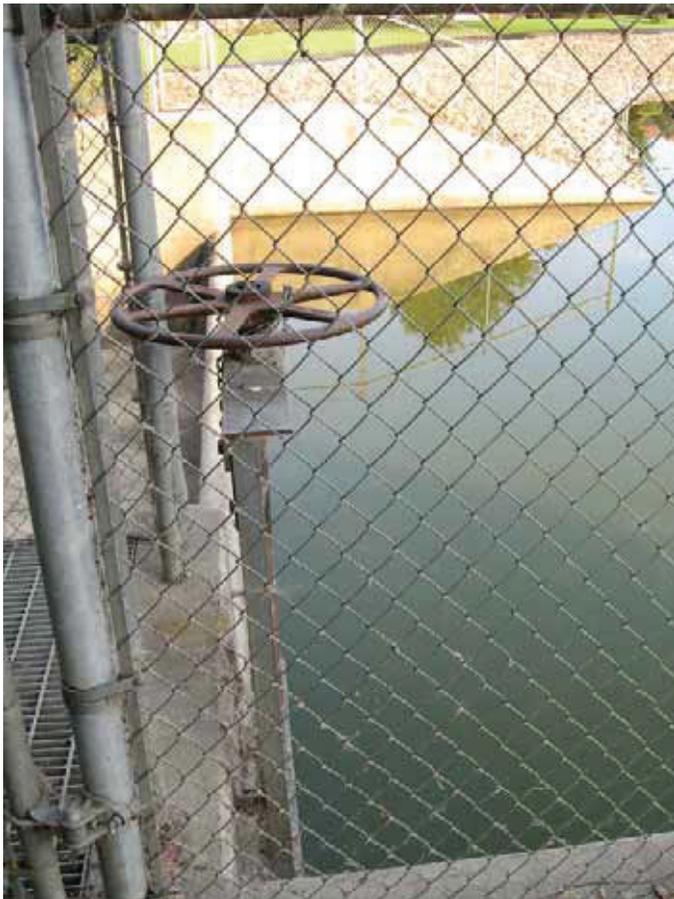
Laguna Joaquin drain valve to drainage channel

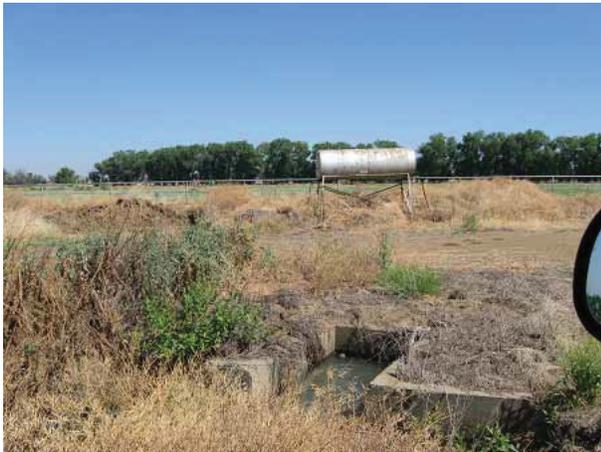
Outlet box on Ranch by racetrack

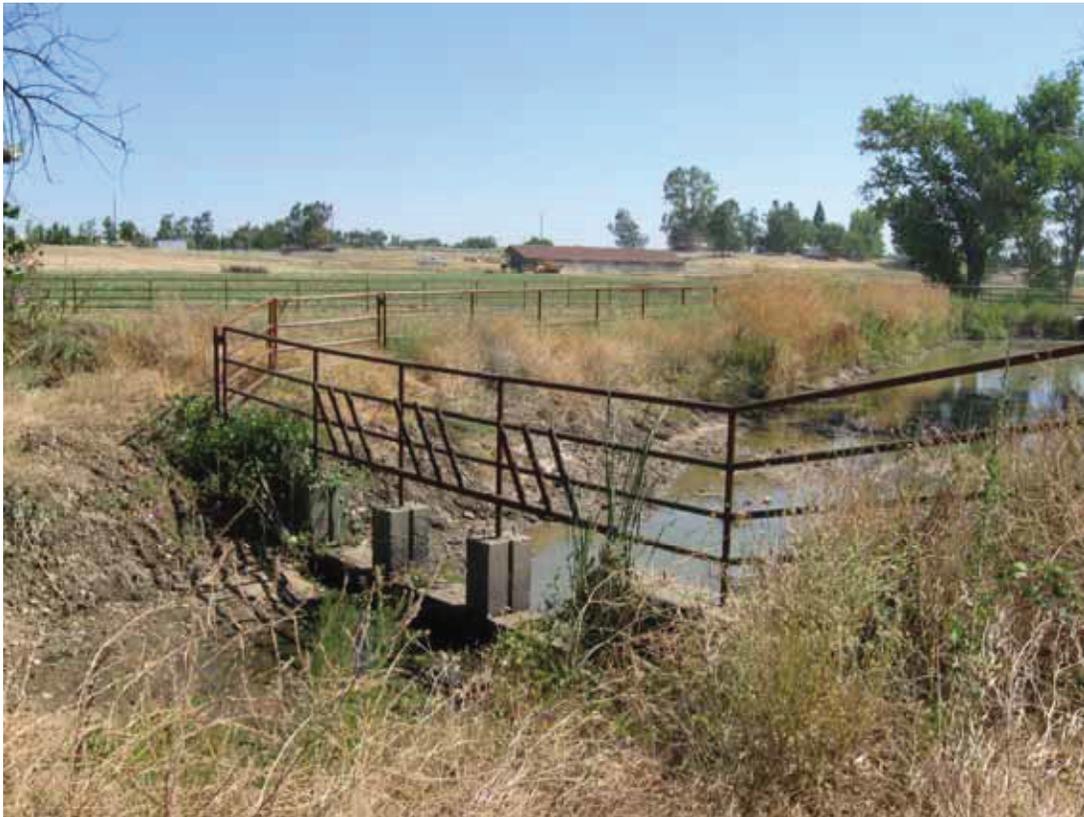
Drainage catchment located on Anderson ranch
