RANCHO MURIETA COMMUNITY SERVICES DISTRICT

Date: June 2, 2021
To: Board of Directors
From: Paula O'Keefe, Director of Administration
Subject: Receive and File Association Reserves, Inc Reserve Study

Update "With-Site-Visit" Capital Funding Plan

Rancho Murieta Community Services Dist. Admin Rancho Murieta, CA

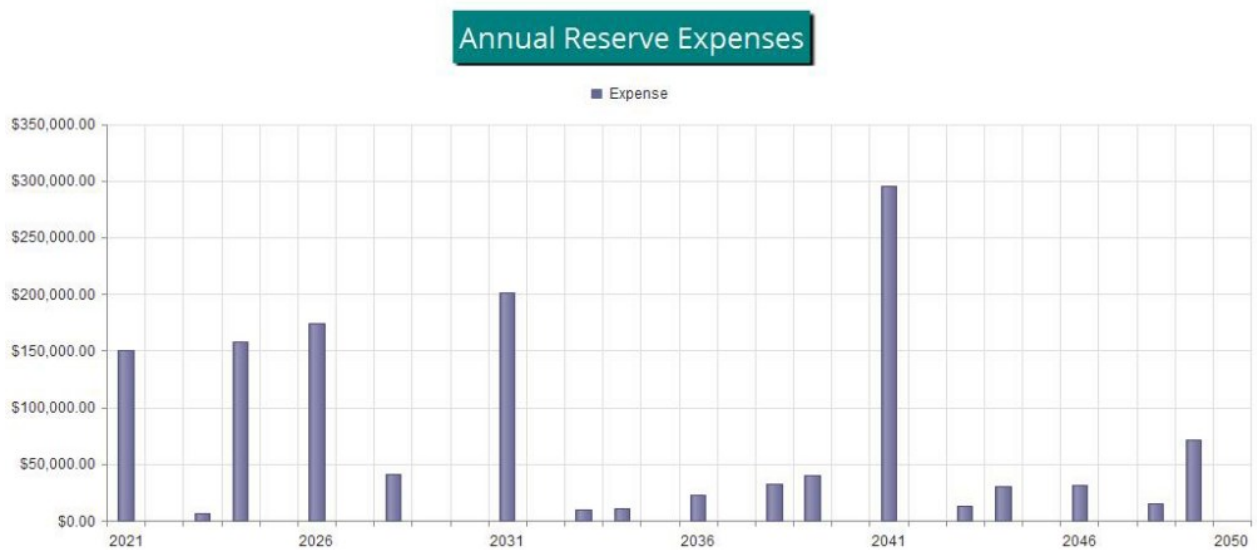
Figure 1

The figure below summarizes the projected future expenses at your property as defined by your Reserve Component List. A summary of these components is shown in the Component Details table, while a summary of the expenses themselves are shown in the 30-yr Expense Summary table.

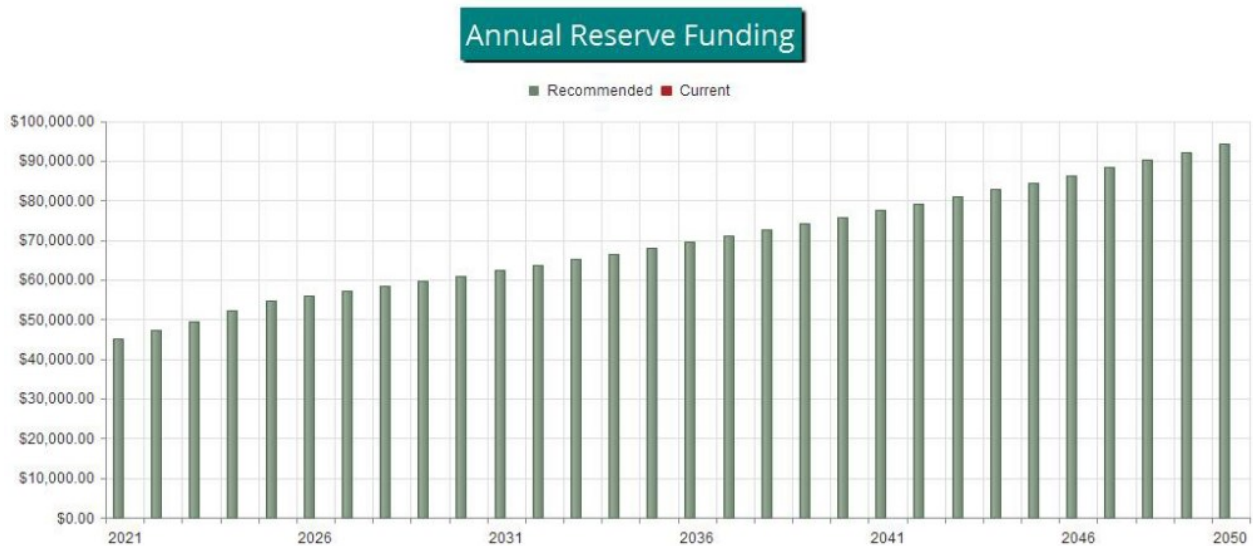
Figure 2

Based on your current Percent Funded and your near-term and long-term Reserve needs, we are recommending budgeted contributions of \$45,000/Annual this Fiscal Year. The overall 30-yr plan, in perspective, is shown below. This same information is shown numerically in both the 30-yr Summary and the Cash Flow Detail tables.

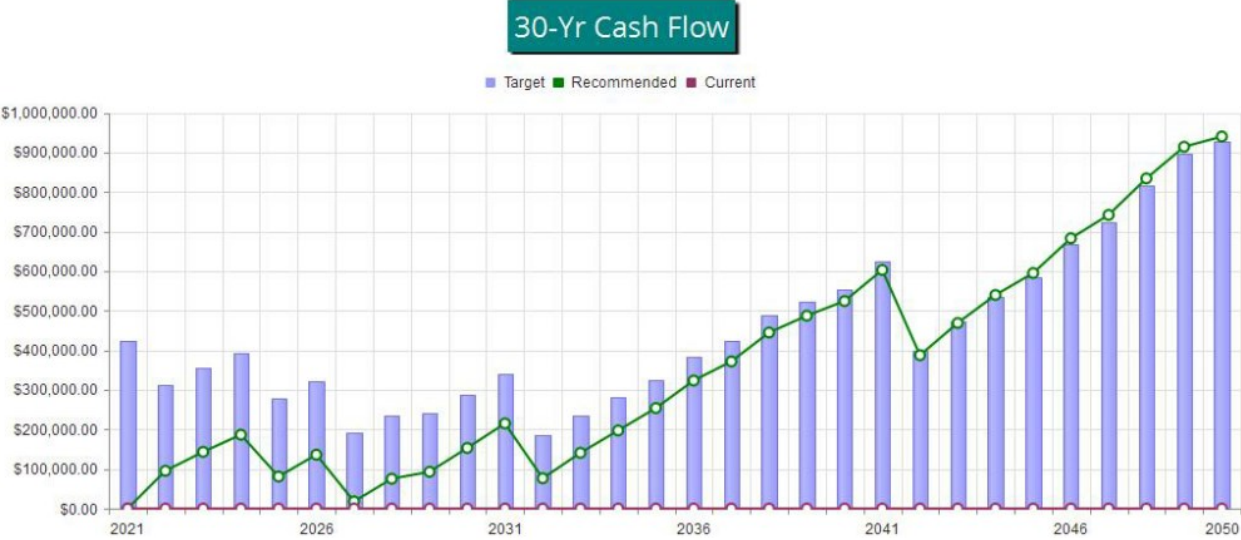
Figure 3

The following chart shows your Reserve balance under our recommended Full Funding Plan and at your current budgeted contribution rate, compared to your always-changing Fully Funded Balance target.

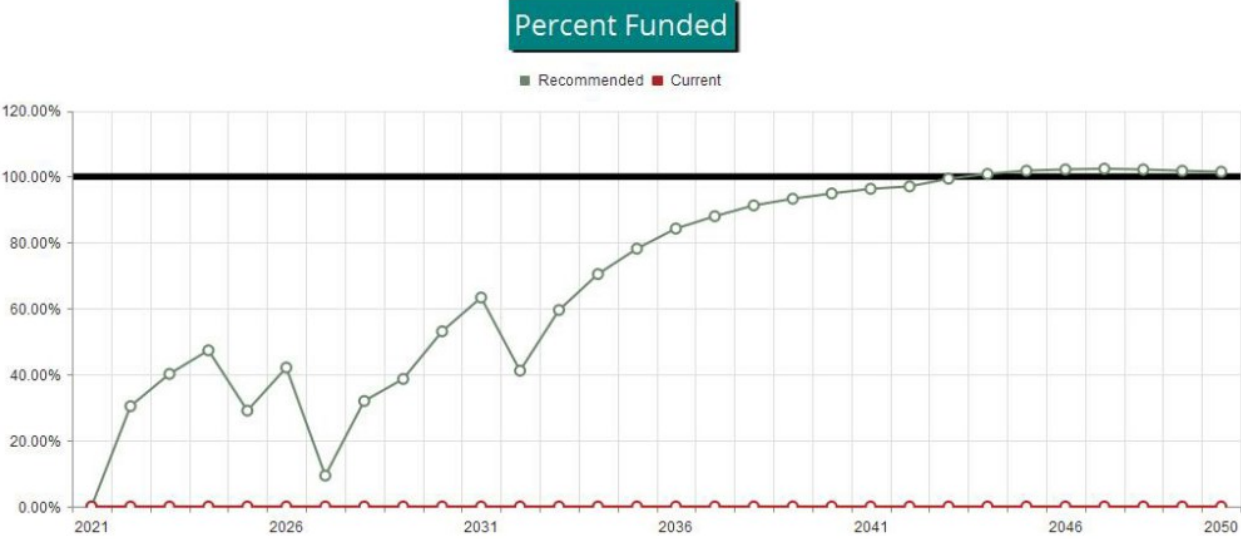
Figure 4

This figure shows the same information plotted on a Percent Funded scale. It is clear here to see how your Reserve Fund strength approaches the 100% Funded level under our recommended multi-yr Funding Plan.

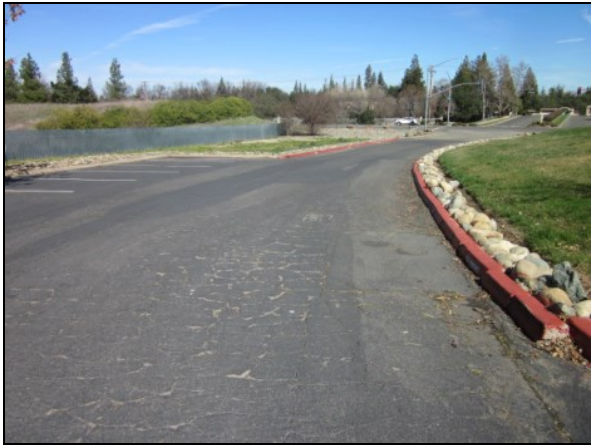
History: Repairs in 2017

Useful Life:
25 years

Remaining Life:
5 years

Best Case: \$ 95,000

Worst Case: \$ 120,000

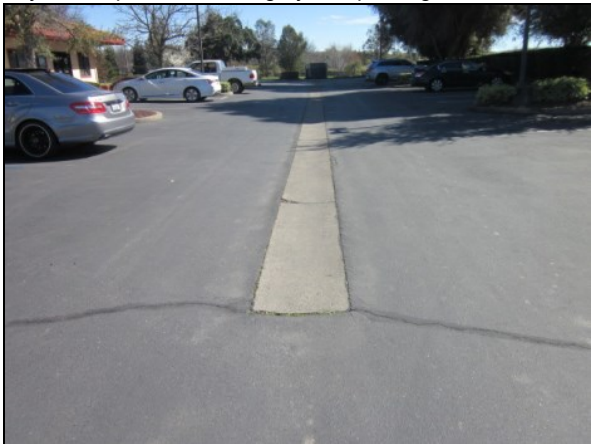
Comp #: 10102 Asphalt - Seal/Repair

Useful Life:
5 years

Remaining Life:
2 years

Best Case: \$ 6,000

Worst Case: \$ 7,200

Lower allowance to seal/repair

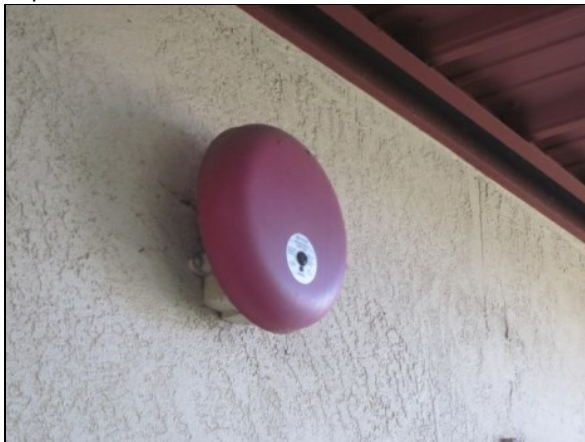
Useful Life:
15 years

Remaining Life:
5 years

Best Case: \$ 12,000

Worst Case: \$ 15,000

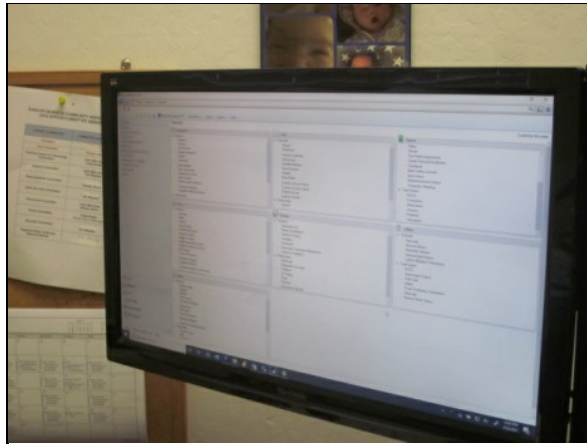
Useful Life:
10 years

Remaining Life:
0 years

Best Case: \$ 125,000

Worst Case: \$ 175,000

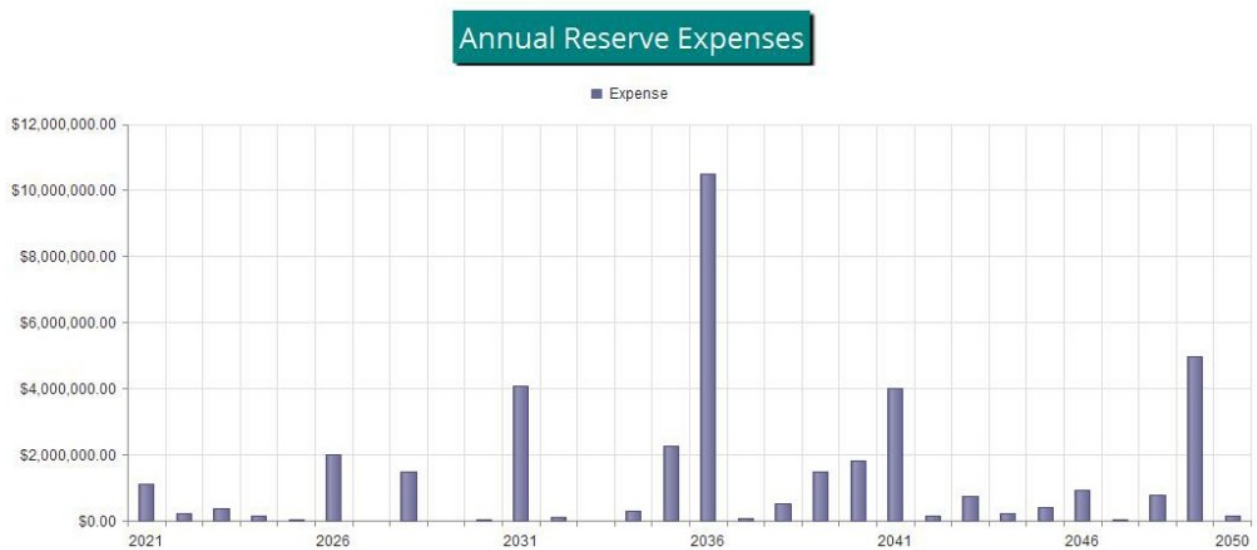
Figure 1

The figure below summarizes the projected future expenses at your property as defined by your Reserve Component List. A summary of these components is shown in the Component Details table, while a summary of the expenses themselves are shown in the 30-yr Expense Summary table.

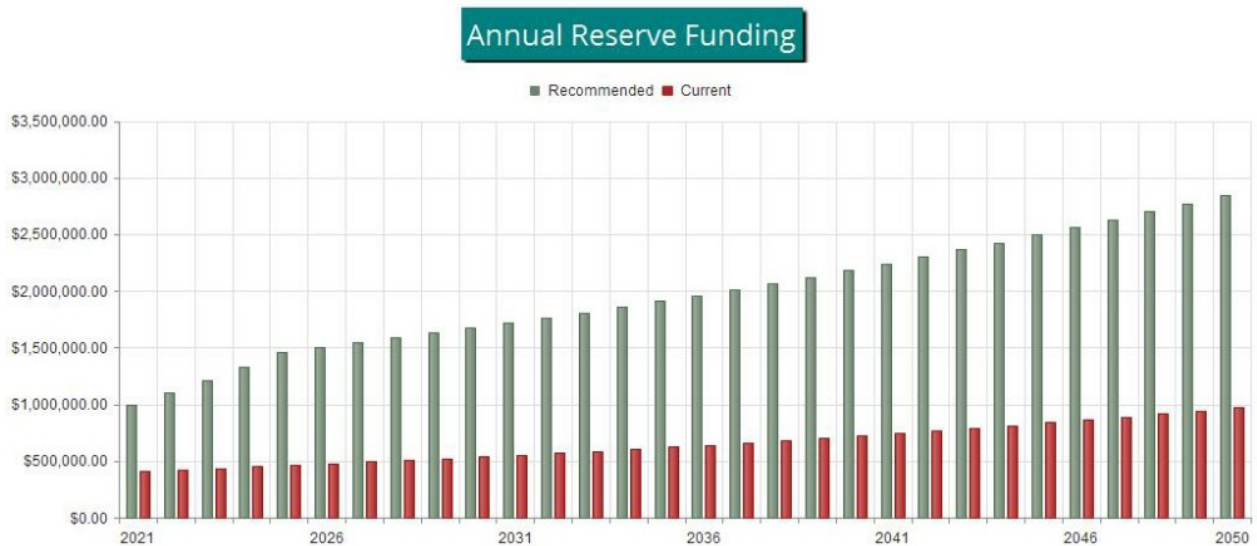
Figure 2

Based on your current Percent Funded and your near-term and long-term Reserve needs, we are recommending budgeted contributions of \$1,000,000/Annual this Fiscal Year. The overall 30-yr plan, in perspective, is shown below. This same information is shown numerically in both the 30-yr Summary and the Cash Flow Detail tables.

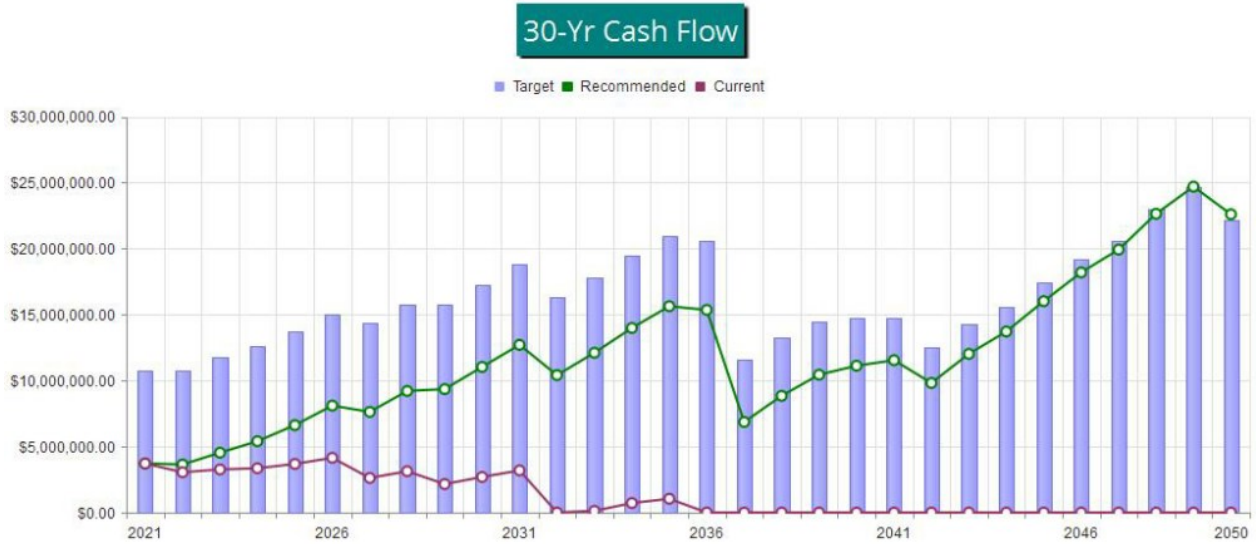
Figure 3

The following chart shows your Reserve balance under our recommended Full Funding Plan and at your current budgeted contribution rate, compared to your always-changing Fully Funded Balance target.

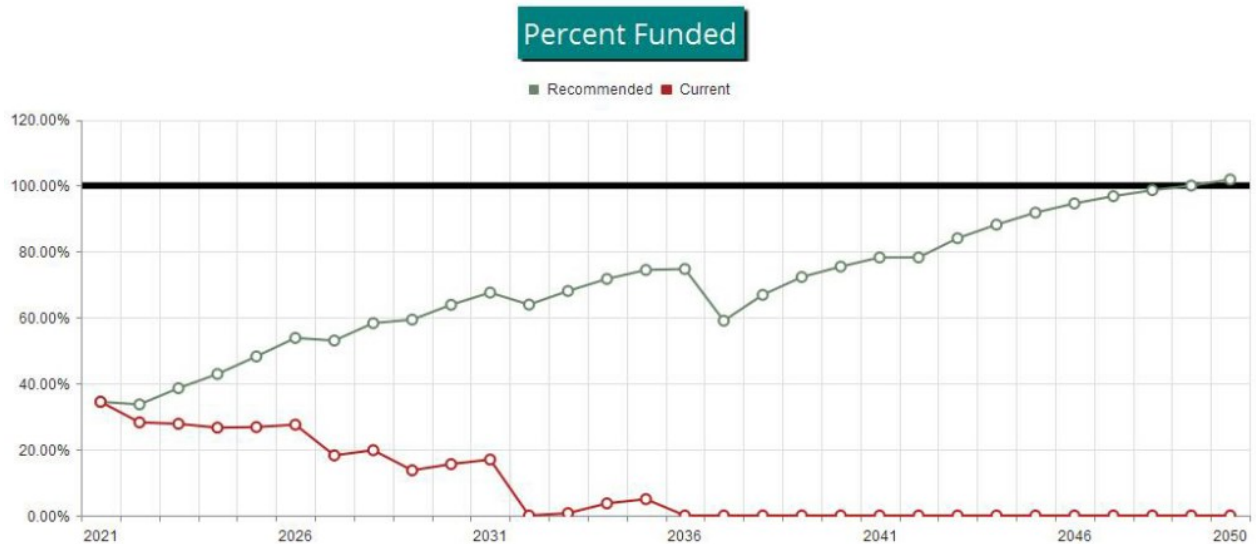
Figure 4

This figure shows the same information plotted on a Percent Funded scale. It is clear here to see how your Reserve Fund strength approaches the 100% Funded level under our recommended multi-yr Funding Plan.

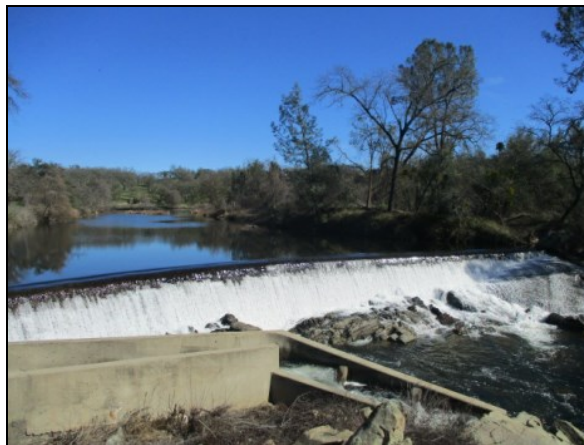
Comp #: 50326 Granlees Forebay Struct - Repair

History: Repaired in 2014.

Comments: Granlees Diversion Station. RMCS D diverts water from the Cosumnes River into the CIA Ditch (Cosumnes Irrigation Association) from Nov. 1-May 31st of each year for raw water storage. Amount and times vary depending on river levels. During our site inspection it was pointed out the the structure shows signs of cracking/movement. We recommend a professional inspection.

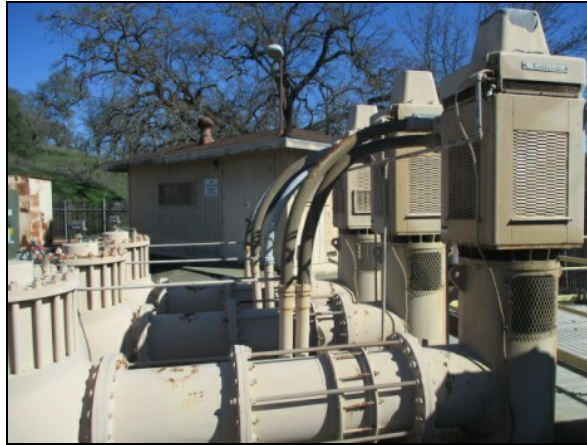
Comp #: 50327 Granlees Pump Station - Repair

Comments: Granlees Dam Pumping & Diversion station pumps water to Calero Reservoir. (3) 500HP Pumps and (2) 150HP Pumps. No expectation to replace completely. This component provides funding for periodic repairs/replacement of pumps at roughly the interval listed below. Update timing and cost as future needs dictate.

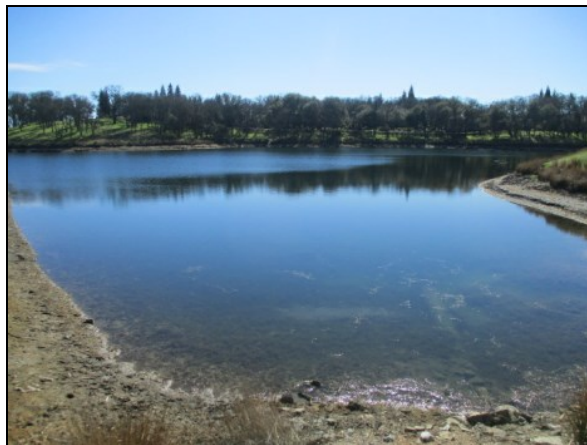
Comp #: 50328 Water Reservoirs - Repair

Comments: (3) Reservoirs throughout the CSD. Calero - 2,630 Acres. Fed from Granlees pump station. Gravity feeds when level is high to Chesbro or is siphoned when level is lower. Chesbro - 1,131 Acres, Gravity feeds to Water Plant for water production. Clementia - 907 Acres, may be pumped to Water Plant as an emergency water source. This component provides funding for periodic repairs as needed.

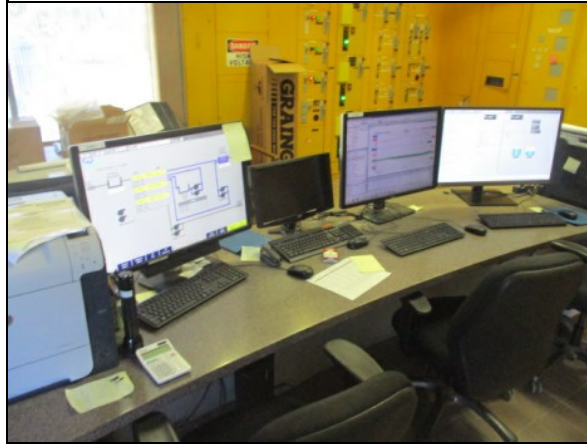
Comp #: 50403 Equipment - Replace

Comments: This component provides funding for periodic replacement of meters, reading devices, recorders, valve operators, and other equipment at roughly the interval below. Update as future needs dictate.

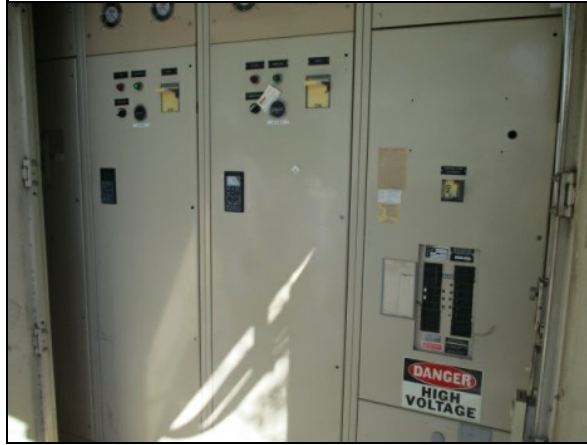
Comp #: 50405 Rio Oso Equip. - Replace

Comments: (1) 230kw Generator, (1) 480 V Transfer switch. This component provides funding to replace the generator and transfer switch at roughly the interval below.

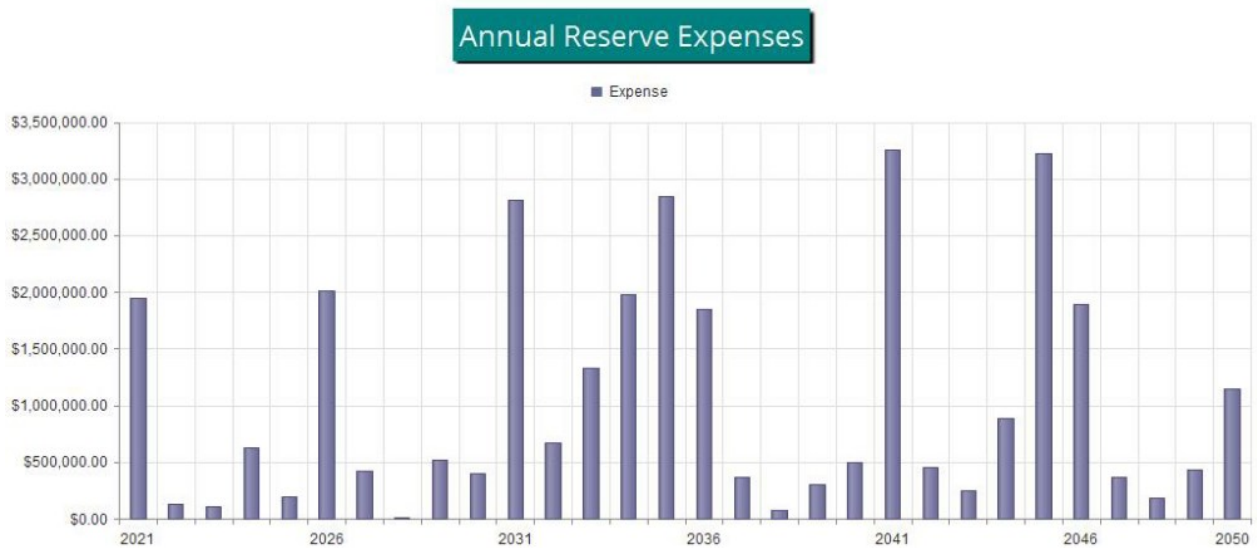
Figure 1

The figure below summarizes the projected future expenses at your property as defined by your Reserve Component List. A summary of these components is shown in the Component Details table, while a summary of the expenses themselves are shown in the 30-yr Expense Summary table.

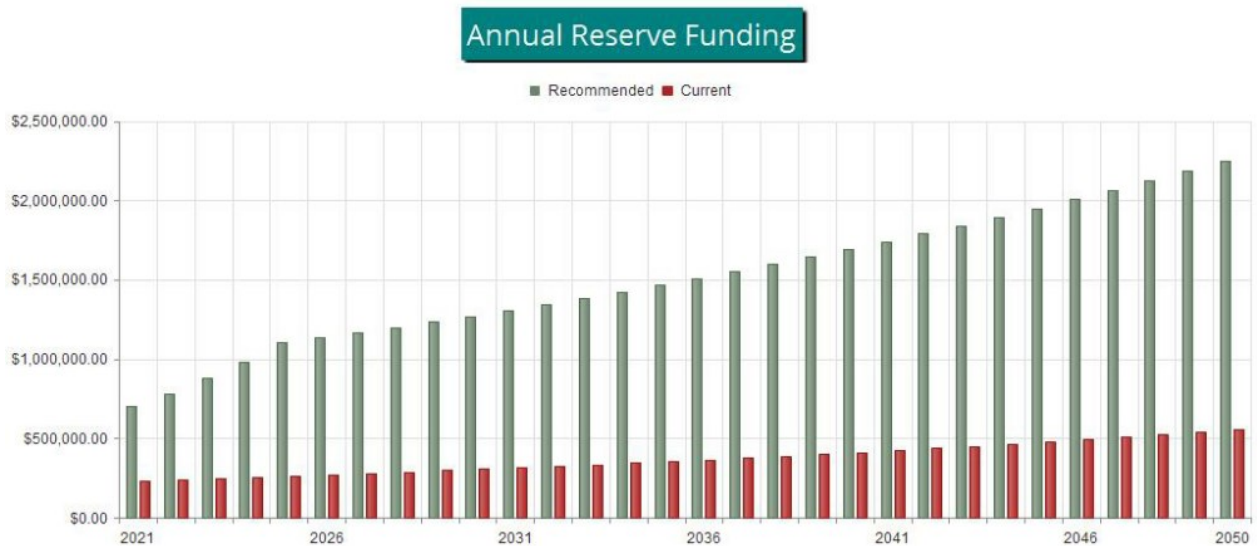
Figure 2

Based on your current Percent Funded and your near-term and long-term Reserve needs, we are recommending budgeted contributions of \$700,000/Annual this Fiscal Year. The overall 30-yr plan, in perspective, is shown below. This same information is shown numerically in both the 30-yr Summary and the Cash Flow Detail tables.

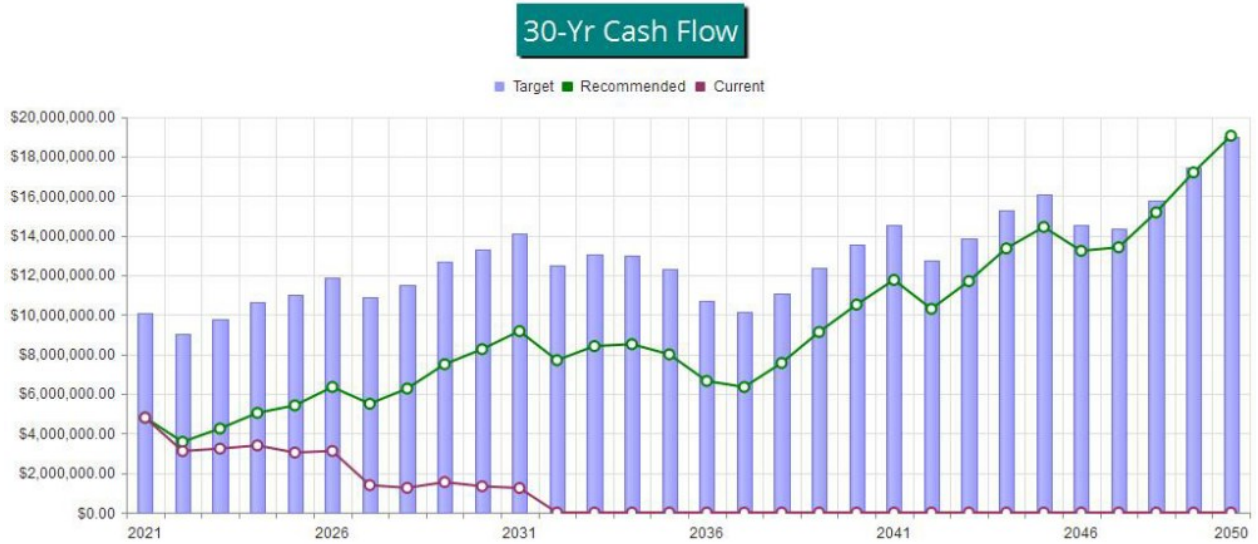
Figure 3

The following chart shows your Reserve balance under our recommended Full Funding Plan and at your current budgeted contribution rate, compared to your always-changing Fully Funded Balance target.

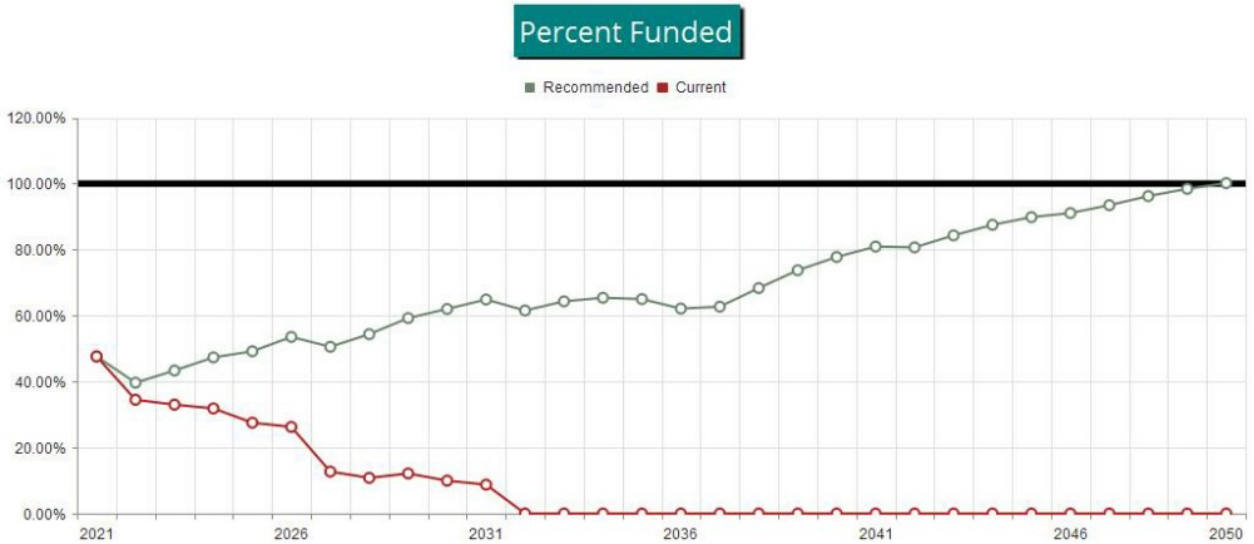
Figure 4

This figure shows the same information plotted on a Percent Funded scale. It is clear here to see how your Reserve Fund strength approaches the 100% Funded level under our recommended multi-yr Funding Plan.

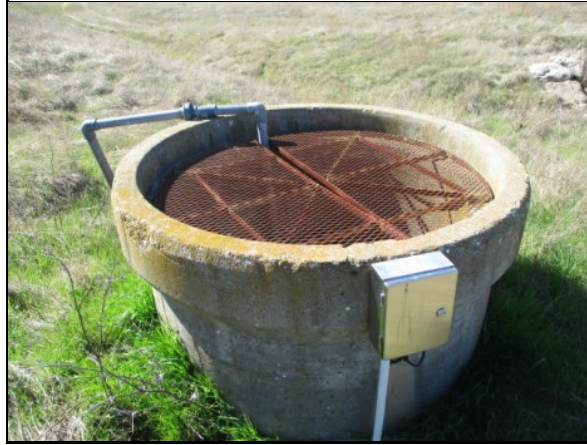
Useful Life:
40 years

Remaining Life:
15 years

Best Case: \$ 10,000

Worst Case: \$ 20,000

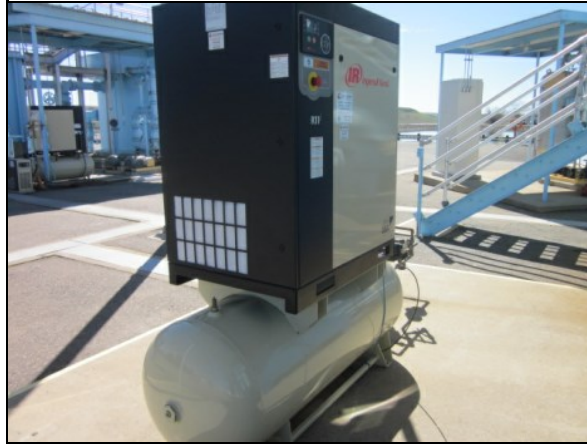
Useful Life:
10 years

Remaining Life:
9 years

Best Case: \$ 35,300

Worst Case: \$ 49,500

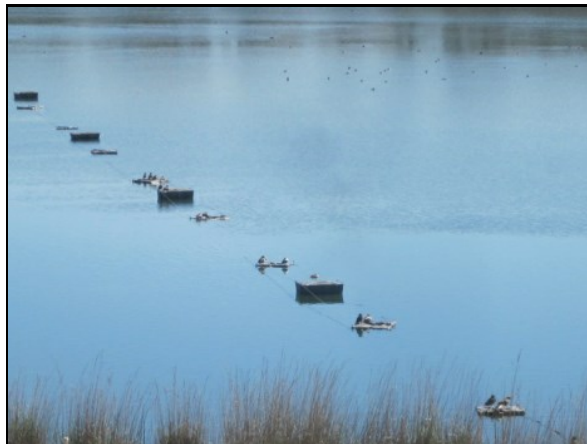
Useful Life:
10 years

Remaining Life:
1 years

Best Case: \$ 60,300

Worst Case: \$ 72,100

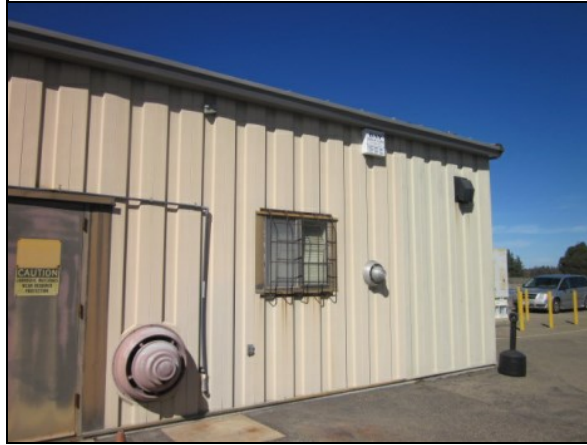
Comments: Functional and intact. No significant chipping or peeling. The exterior surfaces are in fair condition at this time. We recommend repainting every 12-15 years to maintain the appearance of the facility and to protect exterior surfaces.

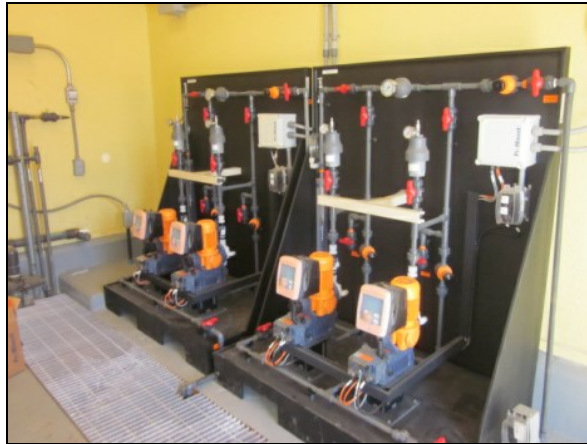
Comp #: 40230 Chemical System Pumps - Replace

Comments: No problems reported at this time. Life can vary depending on use and maintenance. Inspect for performance/leaks and handle minor repairs as needed out of the Operating account. Funding below is for future replacement.

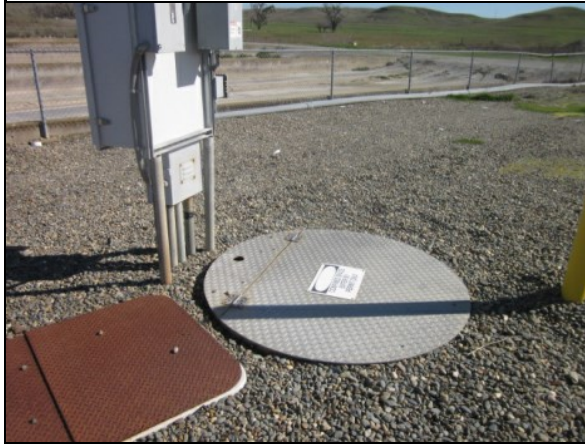
Comp #: 40231 Drying Bed Pump - Replace

Comments: Life can vary depending on use and maintenance. Inspect for performance/leaks and handle minor repairs as needed out of the Operating account. Funding below is for future replacement.

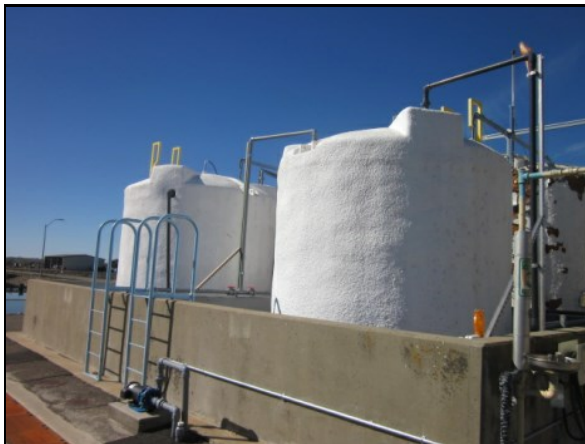
Comp #: 40232 Chemical Control System - Replace

Comments: In most cases, chemical controller systems can be repaired in sections and individual replacement parts do not meet threshold for Reserve funding.

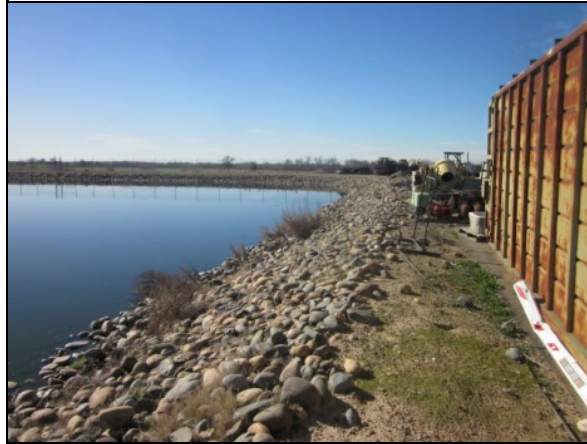
Comp #: 40233 WWT Holding Ponds - Repair

Comments: (4) Ponds, (2) Reservoirs. Approx 364,765 GSF - Ponds. EQ Basin is funded separately in Comp #1904. Approx 1,202,355 GSF of Reservoir. A series of (5) ponds treats wastewater daily. Wastewater is moved from one pond to the next in order of treatment. Treated wastewater is then stored in (2) reservoirs until needed for reclamation use by RMCC during summer months. No expectation for replacement. This component provides funding for periodic repairs for the ponds as needed.

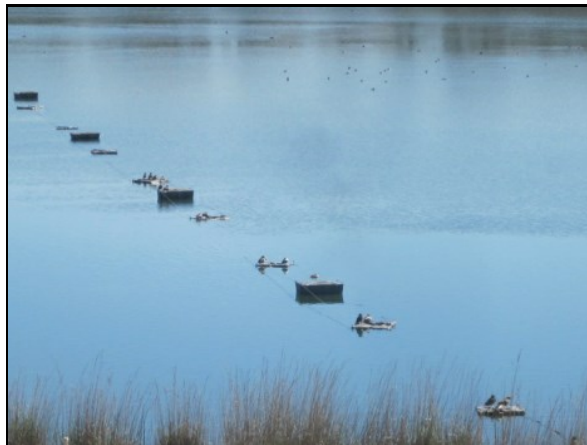
Comp #: 40234 Floating Aerators - Replace

Comments: Assume functional, no issues reported. This component provides funding for replacement at roughly the interval below. Update timing and cost as future needs dictate.

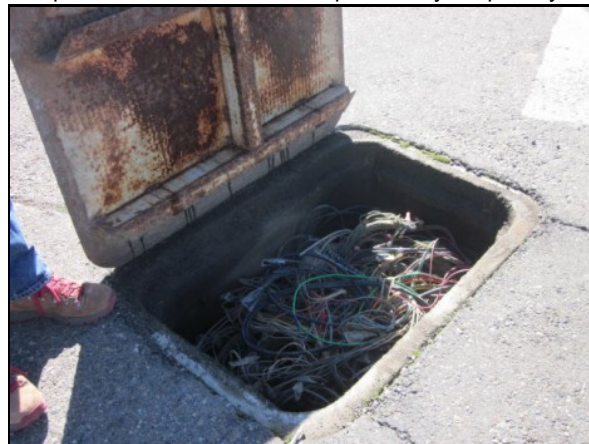
Comp #: 40240 Electrical - Repair/Replace

Comments: Assessing the electrical systems is beyond the scope of our services. Typically, if installed per architectural specifications and local building codes, there is no predictable time frame for large-scale repair/replacement expenses within the scope of our report. This component provides an allowance for repairs every couple of years.

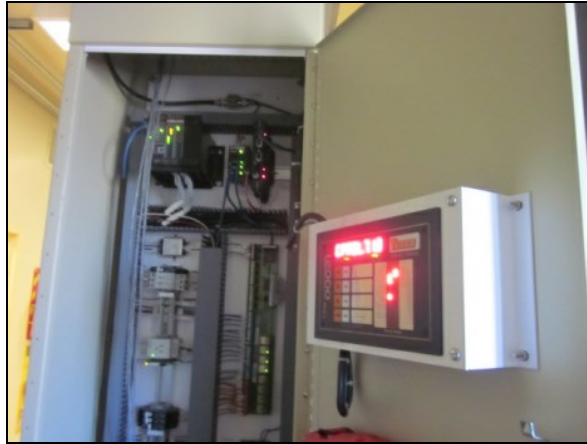
Comp #: 40241 Main PLC (2008) - Replace

Comments: Computers and other IT equipment have a relatively short useful life (depending on the application and level of use) due to advancements in technology. Plan to replace/upgrade the existing equipment at the approximate interval shown here to ensure proper function and uninterrupted service. Keep track of any partial replacements and include cost history during future Reserve Study updates.

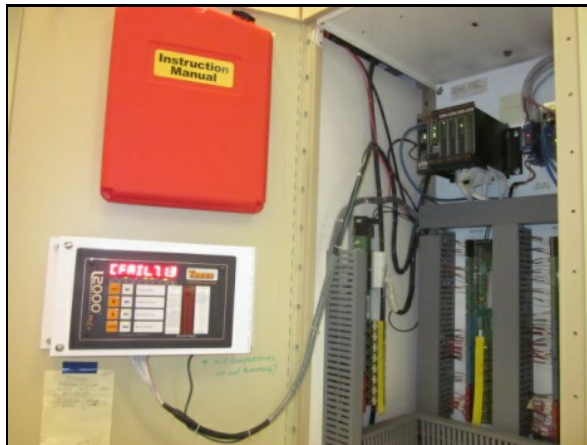
Comp #: 40242 Main PLC (2011) - Replace

Comments: Computers and other IT equipment have a relatively short useful life (depending on the application and level of use) due to advancements in technology. Plan to replace/upgrade the existing equipment at the approximate interval shown here to ensure proper function and uninterrupted service. Keep track of any partial replacements and include cost history during future Reserve Study updates.

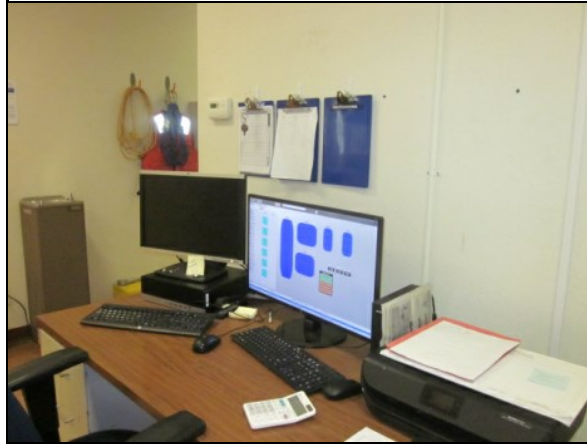
Comp #: 40243 Scada System Software - Replace

Comments: Plan to replace/upgrade the existing equipment at the approximate interval shown here to ensure proper function and uninterrupted service. Keep track of any partial replacements and include cost history during future Reserve Study updates.

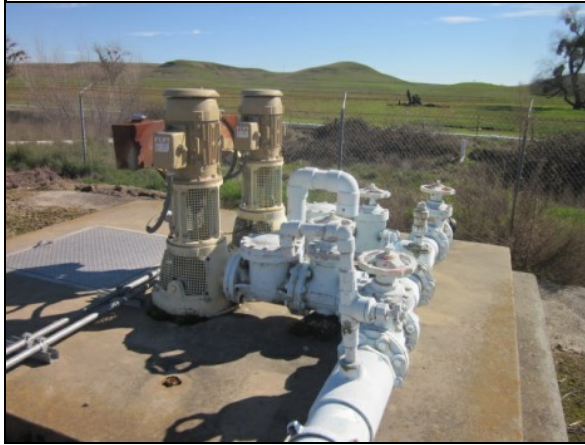
Comp #: 40245 Sub Drain Pumps - Replace

Comments: Pump systems can have a highly variable life expectancy depending on level of use. Should be inspected regularly and repaired as-needed by serving vendor or maintenance staff to ensure proper function and optimal performance.

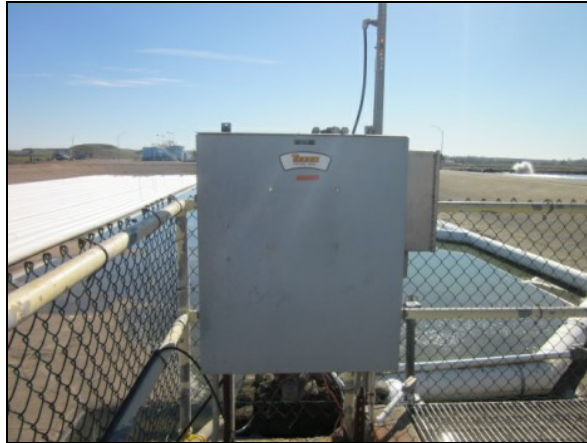
Comp #: 40247 Chlorine Meter - Replace

Comments: Reported to be in functional condition.

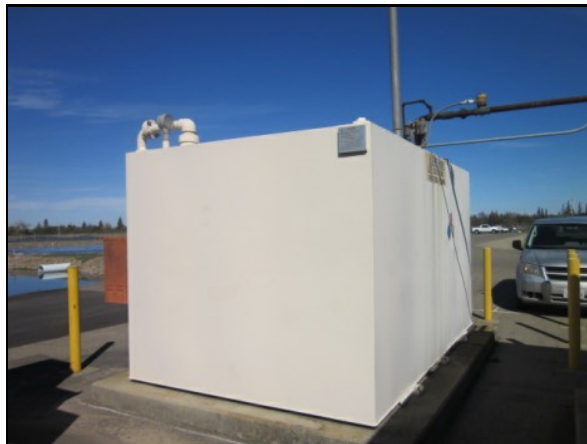
Comp #: 40248 Fuel Tank - Replace

Comments: No problems reported at the time of site visit. Appears to be in good condition with no rusting or leaking noted. This component provides funding for disposal and replacement of the fuel tank at roughly the interval listed below. Update timing and cost as future needs dictate.

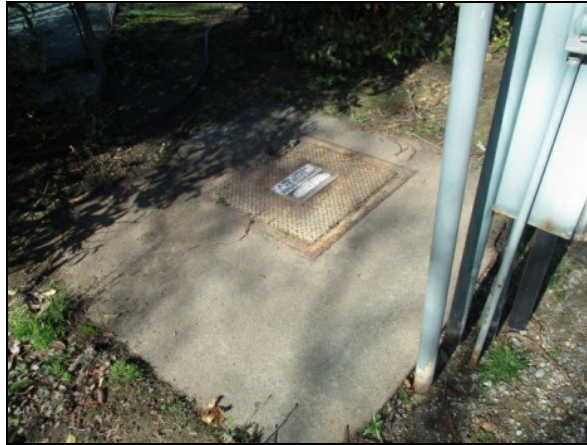
Comments: The Alameda Lift Station is a single function sewage pumping facility. Station has (1) 4" Force Main with approx 464 LF of piping. This component provides funding for minor reconstruction, including repair/replacement of pumps and stainless steel guide rails every 15 years.

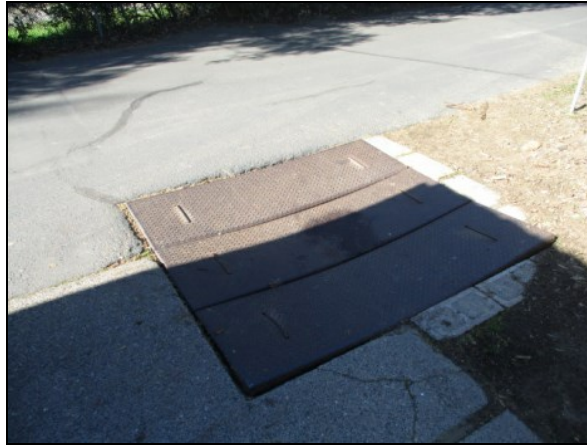
Comments: The Starter Shack Lift Station is a single function sewage pumping facility. Station has (1) 2" Force Main with approx 18 LF of piping. This component provides funding for minor reconstruction, including repair/replacement of pumps and stainless steel guide rails every 15 years.

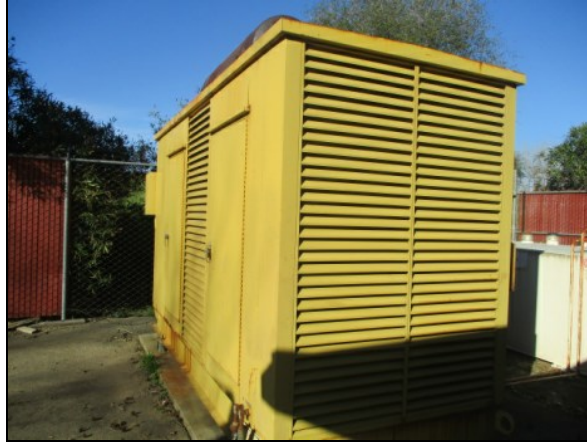
Comments: The Main Lift South Lift Station is a dual-function facility. Station has (1) 10" Force Main with approx 3,005LF of piping. Lift Station pumps directly to the Wastewater facility. Average monthly flow of 140,000 gallons per day. Equipment includes; control panels, motor control center, PLC & Meter readouts, (1) backup generator, (2) sewage grinders, (3) sewage pumps, and (1) above ground 2,000 gallon diesel storage tank. This component provides funding for minor reconstruction, including repair/replacement of pumps and stainless steel guide rails every 15 years.

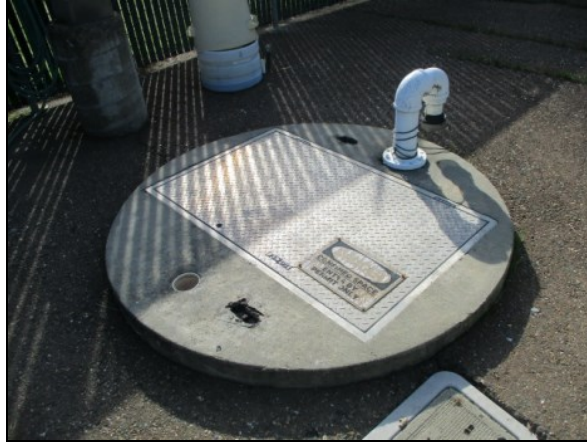
Comments: The Crest sewage lift station serves to pump sewage to Main Lift South. The pump station has (2) 8" sanitary sewer inlets and (1) 6" force main that runs up Murieta South parkway ultimately into Main Lift South with approx 1,490LF of piping. Equipment includes; (2) 10HP submersible pumps; a Tesco L2000 controller; a Cummins transfer switch; Microtel DialStat auto-dialer; a 6" Sparling magnetic flow meter; a 68hp diesel generator; and a 113 Gallon Fuel Tank. This component provides funding for minor reconstruction, including repair/replacement of pumps and stainless steel guide rails every 15 years.

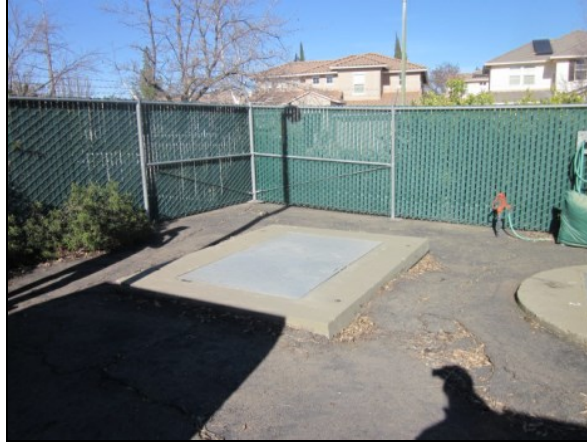
Comments: The Greens sewage lift station serves to pump sewage to Main Lift South. Station has (1) 6" inch sanitary sewer inlets and (1) 4" force main that runs up Bent Grass Court, north on Colbert Drive and ultimately flows into Main Lift South with approx 670LF of piping. Equipment includes; (2) 3HP submersible pumps; Tesco L2000 controller, a Cummins transfer switch; a Sensaphone auto-dialer; 24.3 HP diesel generator; and a 106 gallon diesel storage tank. This component provides funding for minor reconstruction, including repair/replacement of pumps and stainless steel guide rails every 15 years.

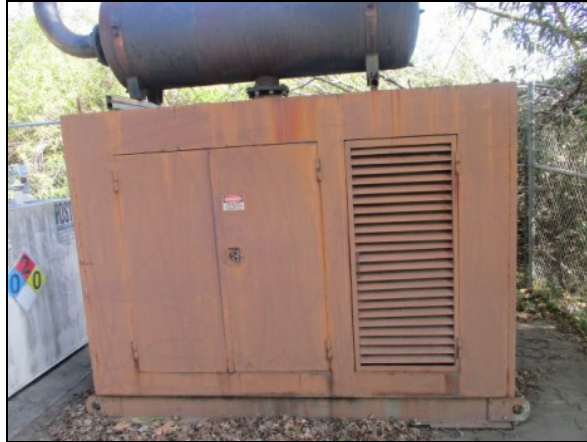
Comp #: 40323 Main Lift N Generator - Replace

Comments: Have service vendor assess overall condition and if predictable basis for replacement or overhaul is determined, include funding within future reserve study update(s).

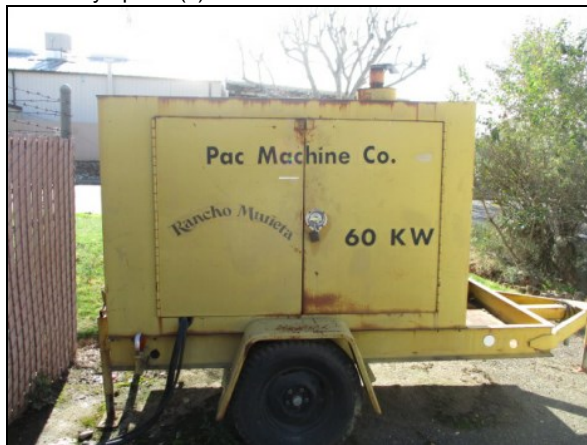
Comp #: 40324 Cantova Generator - Replace

Comments: Have service vendor assess overall condition and if predictable basis for replacement or overhaul is determined, include funding within future reserve study update(s).

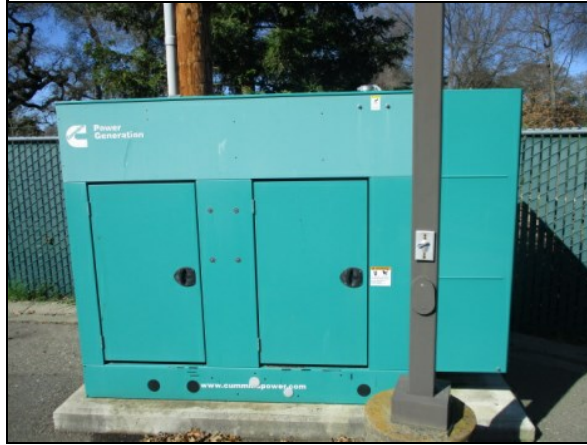
Comp #: 40325 6B Generator - Replace

Comments: Have service vendor assess overall condition and if predictable basis for replacement or overhaul is determined, include funding within future reserve study update(s).

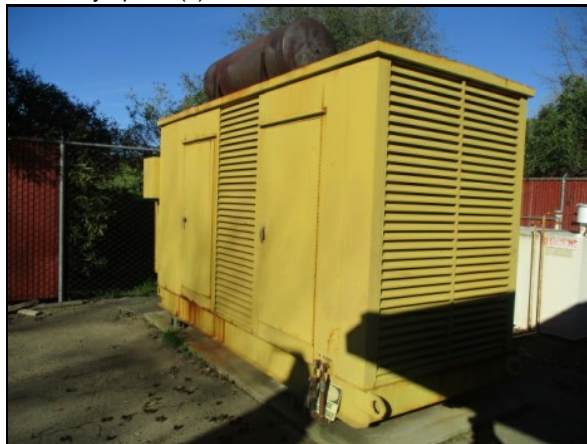
Comp #: 40326 Main Lift S Generator - Replace

Comments: Have service vendor assess overall condition and if predictable basis for replacement or overhaul is determined, include funding within future reserve study update(s).

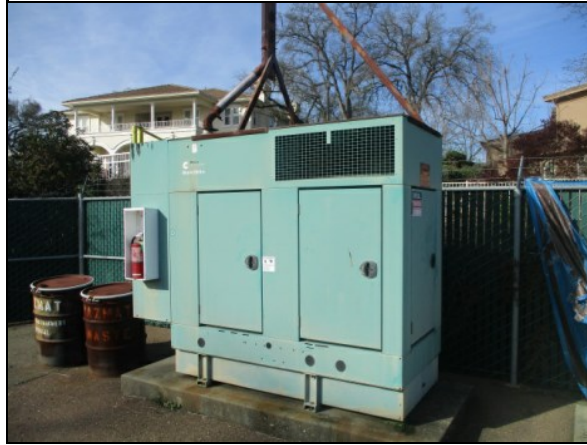
Comp #: 40327 Crest Generator - Replace

Comments: Have service vendor assess overall condition and if predictable basis for replacement or overhaul is determined, include funding within future reserve study update(s).

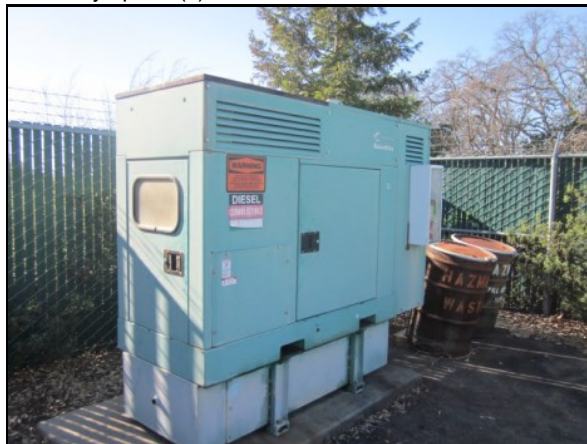
Comp #: 40328 Greens Generator - Replace

Comments: Have service vendor assess overall condition and if predictable basis for replacement or overhaul is determined, include funding within future reserve study update(s).

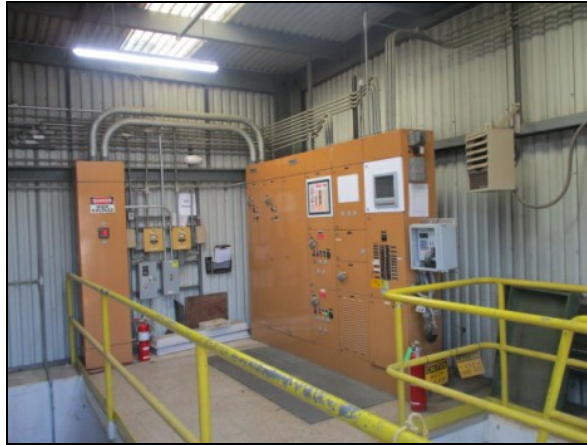
Comp #: 40329 Main Lift N Control Panel - Replace

Comments: Life of control systems can vary depending upon system needs, operator desires for management capabilities, manufacturers support, parts obsolescence, etc. Plan for replacement around the typical life expectancy as indicated below. Discuss system needs/efficiencies and current functionality with your mechanical vendor or consultant.

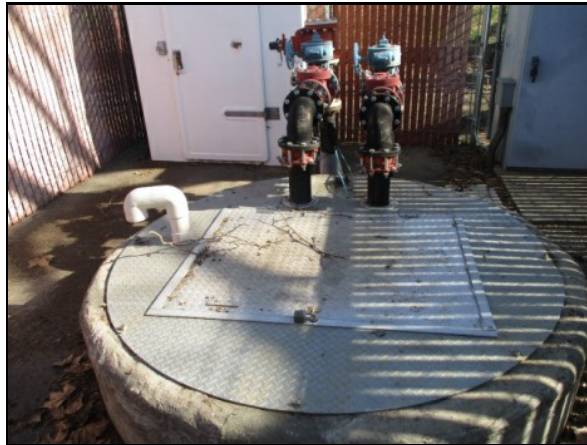
Comp #: 40330 Cantova Control Panel - Replace

Comments: Life of control systems can vary depending upon system needs, the operator desires for management capabilities, manufacturers support, parts obsolescence, etc. Plan for replacement around the typical life expectancy as indicated below. Discuss system needs/efficiencies and current functionality with your mechanical vendor or consultant.

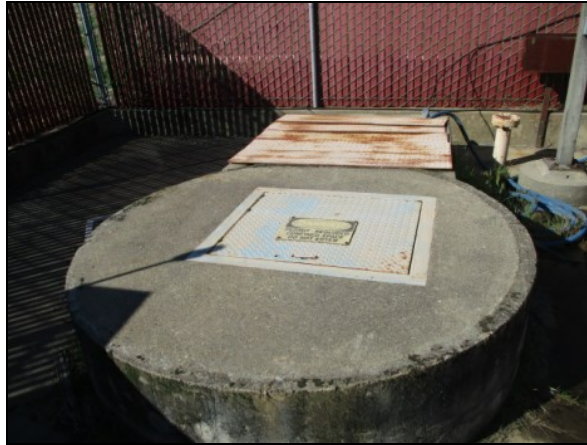
Comp #: 40331 FAA Control Panel - Replace

Comments: Life of control systems can vary depending upon system needs, operator desires for management capabilities, manufacturers support, parts obsolescence, etc. Plan for replacement around the typical life expectancy as indicated below. Discuss system needs/efficiencies and current functionality with your mechanical vendor or consultant.

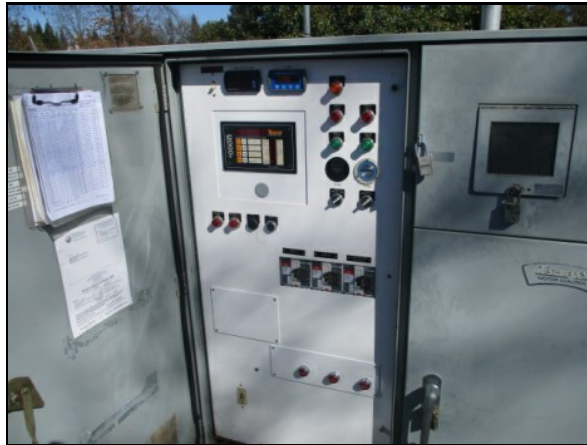
Comp #: 40332 6B Control Panel - Replace

Comments: Life of control systems can vary depending upon system needs, operator desires for management capabilities, manufacturers support, parts obsolescence, etc. Plan for replacement around the typical life expectancy as indicated below. Discuss system needs/efficiencies and current functionality with your mechanical vendor or consultant.
