RANCHO MURIETA COMMUNITY SERVICES DISTRICT

Date: June 2, 2021
To: Board of Directors
From: Paula O'Keefe, Director of Administration
Subject: Receive and File Association Reserves, Inc Reserve Study

Update "With-Site-Visit" Capital Funding Plan

Rancho Murieta Community Services Dist. Admin Rancho Murieta, CA

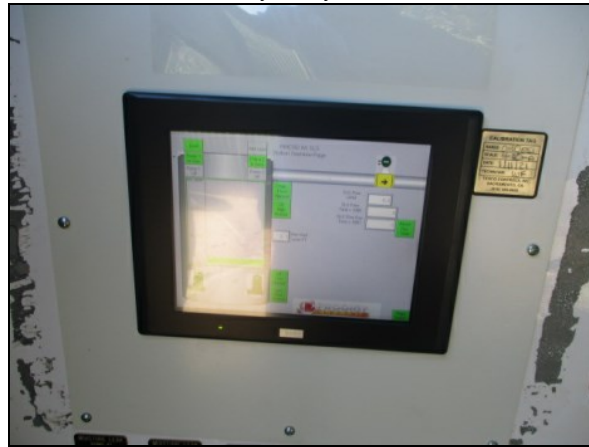
Comp #: 40333 6A Control Panel - Replace

Comments: Life of control systems can vary depending upon system needs, operator desires for management capabilities, manufacturers support, parts obsolescence, etc. Plan for replacement around the typical life expectancy as indicated below. Discuss system needs/efficiencies and current functionality with your mechanical vendor or consultant.

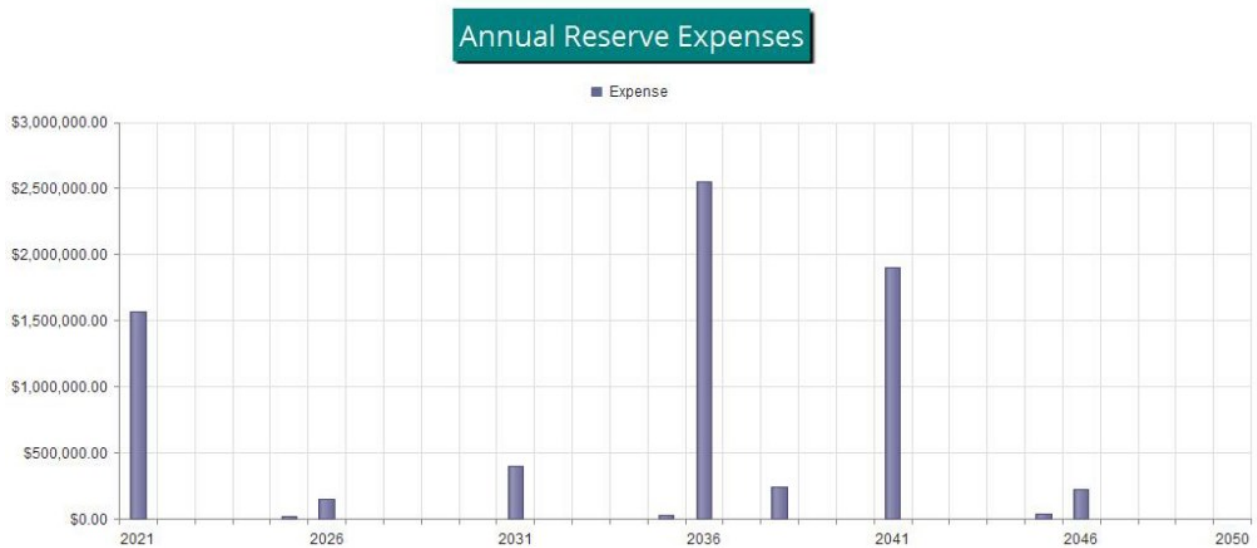
Figure 1

The figure below summarizes the projected future expenses at your property as defined by your Reserve Component List. A summary of these components is shown in the Component Details table, while a summary of the expenses themselves are shown in the 30-yr Expense Summary table.

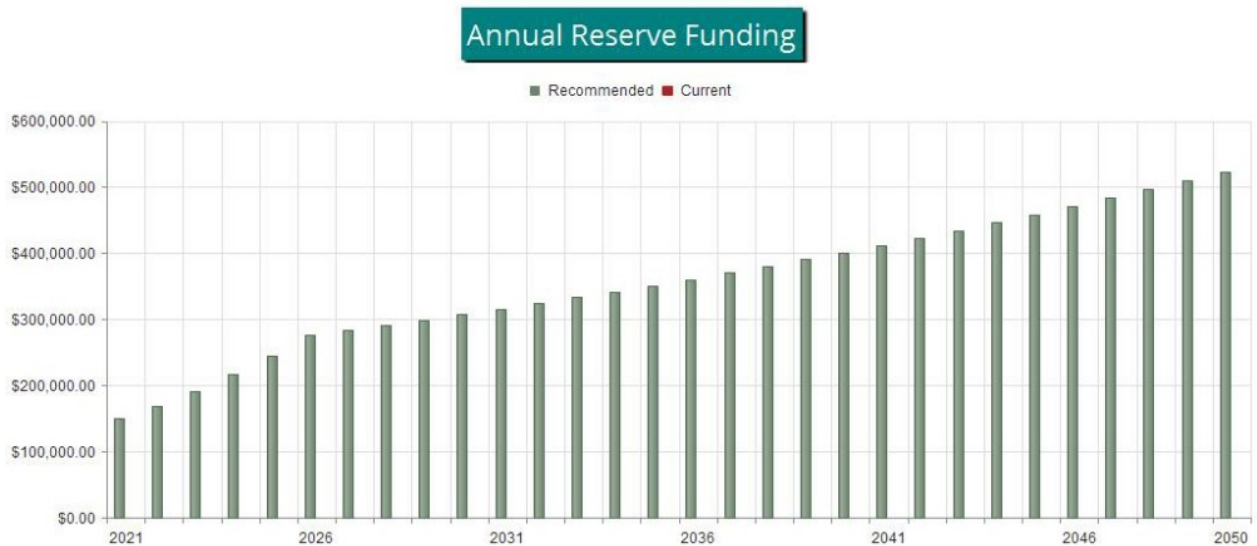
Figure 2

Based on your current Percent Funded and your near-term and long-term Reserve needs, we are recommending budgeted contributions of \$150,000/Annual this Fiscal Year. The overall 30-yr plan, in perspective, is shown below. This same information is shown numerically in both the 30-yr Summary and the Cash Flow Detail tables.

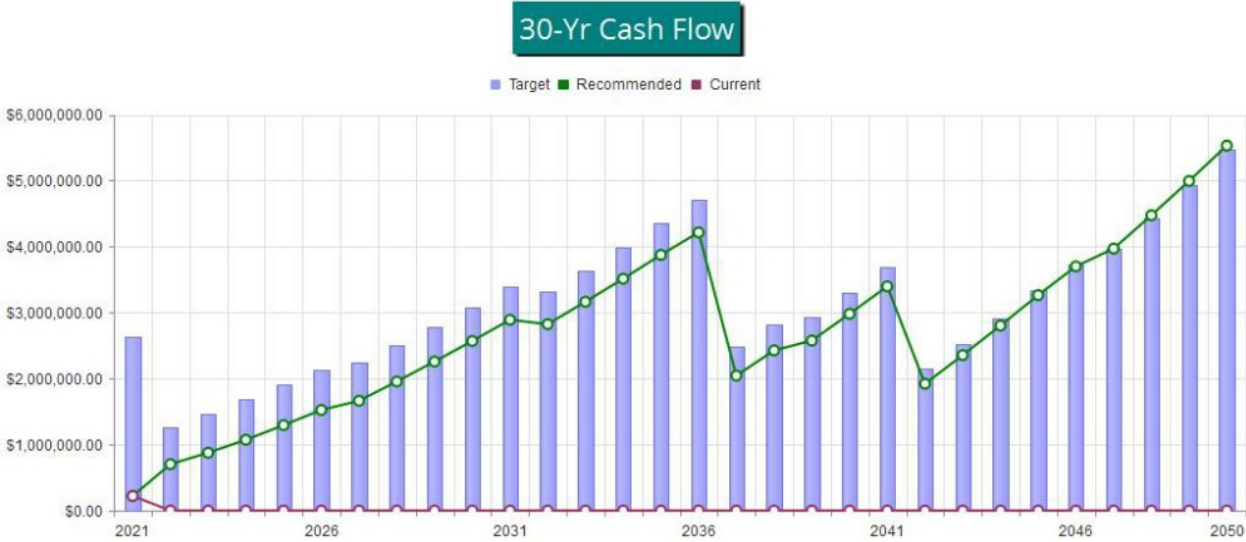
Figure 3

The following chart shows your Reserve balance under our recommended Full Funding Plan and at your current budgeted contribution rate, compared to your always-changing Fully Funded Balance target.

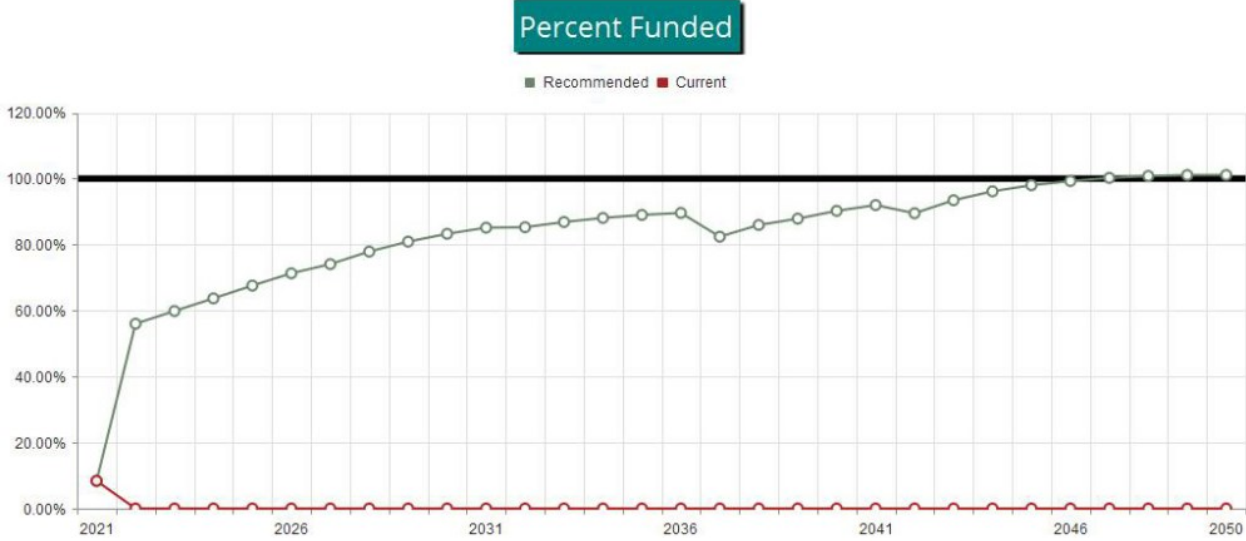
Figure 4

This figure shows the same information plotted on a Percent Funded scale. It is clear here to see how your Reserve Fund strength approaches the 100% Funded level under our recommended multi-yr Funding Plan.

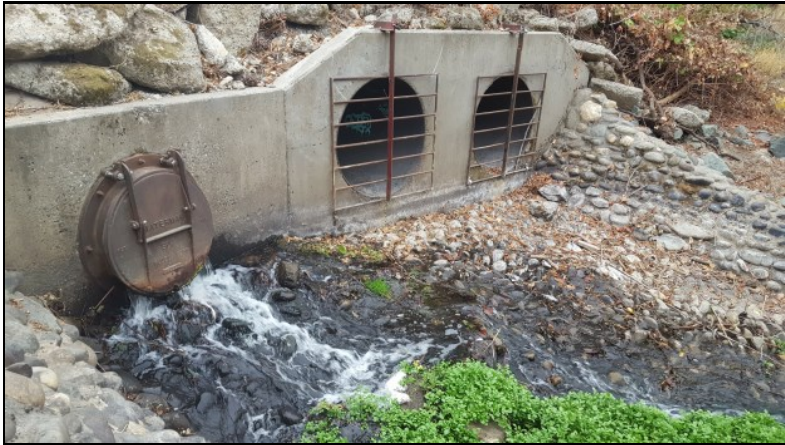
Comp #: 20101 Storm Water Outfall Struct. Repair

Useful Life:
 50 years

Remaining Life:
 20 years

Best Case: \$ 876,000

Worst Case: \$ 1,050,000

#	Component	Quantity	Useful Life	Rem. Useful Life	Current Cost Estimate	
					Best Case	Worst Case
Drainage						
20101	Storm Water Outfall Struct. Repair	River Outfall Structure	50	20	\$876,000	\$1,050,000
20102	Levees - Repair	Approx 12,900 LF, Levees	100	50	\$355,000	\$591,000
20103	60" Drain Valve - Replace	(1) 60" Drain Valve	30	15	\$59,100	\$70,900
20104	Equipment - Replace	Drainage Equipment	10	4	\$17,700	\$21,300
20105	Drainage Culverts - Repair/Replace	(52) Drainage Culverts	5	0	\$50,000	\$90,000
20107	Main Lift South - Repair/Replace	Storm water Pump Station	20	17	\$118,000	\$177,000
20108	FAA Storm Water - Repair/Replace	Storm water Pump Station	20	5	\$23,600	\$47,300
20109	Laguna Juaquin - Silt Removal	Allowance	15	0	\$1,000,000	\$2,000,000
20110	Basin 5 - Maintenance & Repair	Approx 27,206 GSF, Basin	25	10	\$59,100	\$390,000
20113	Drainage Zone 5, Channel A	Approx 600 LF	15	5	\$15,000	\$25,000

#	Component	Current Cost Estimate	X	Effective Age	/	Useful Life	=	Fully Funded Balance
Drainage								
20101	Storm Water Outfall Struct. Repair	\$963,000	X	30	/	50	=	\$577,800
20102	Levees - Repair	\$473,000	X	50	/	100	=	\$236,500
20103	60" Drain Valve - Replace	\$65,000	X	15	/	30	=	\$32,500
20104	Equipment - Replace	\$19,500	X	6	/	10	=	\$11,700
20105	Drainage Culverts - Repair/Replace	\$70,000	X	5	/	5	=	\$70,000
20107	Main Lift South - Repair/Replace	\$147,500	X	3	/	20	=	\$22,125
20108	FAA Storm Water - Repair/Replace	\$35,450	X	15	/	20	=	\$26,588
20109	Laguna Juaquin - Silt Removal	\$1,500,000	X	15	/	15	=	\$1,500,000
20110	Basin 5 - Maintenance & Repair	\$224,550	X	15	/	25	=	\$134,730
20113	Drainage Zone 5, Channel A	\$20,000	X	10	/	15	=	\$13,333
								\$2,625,276

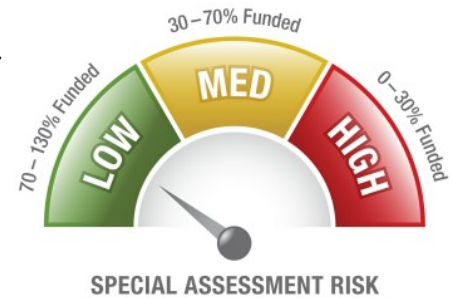
Adequacy is measured in a two-step process:

- 1) Calculate the *value of deterioration* at the property (called Fully Funded Balance, or FFB).
- 2) Compare that to the Capital Fund Balance, and express as a percentage.

Each year, the *value of deterioration* at the property changes. When there is more deterioration (as components approach the time they need to be replaced), there should be more cash to offset that deterioration and prepare for the expenditure. Conversely, the *value of deterioration* shrinks after projects are accomplished. The *value of deterioration* (the FFB) changes each year, and is a moving but predictable target.

There is a high risk of special funding needs and deferred maintenance when the Percent Funded is *weak*, below 30%. Approximately 30% of all properties are in this high risk range. While the 100% point is Ideal (indicating Reserve cash is equal to the *value of deterioration*), a Reserve Fund in the 70% - 130% range is considered strong (low risk of special funding needs).

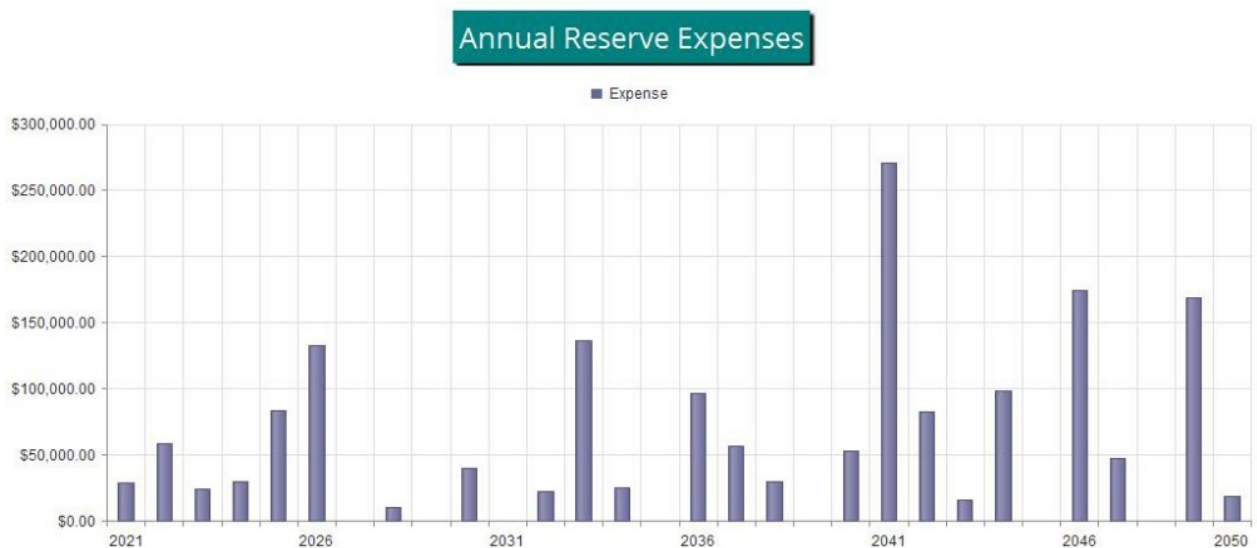
Figure 1

The figure below summarizes the projected future expenses at your property as defined by your Reserve Component List. A summary of these components is shown in the Component Details table, while a summary of the expenses themselves are shown in the 30-yr Expense Summary table.

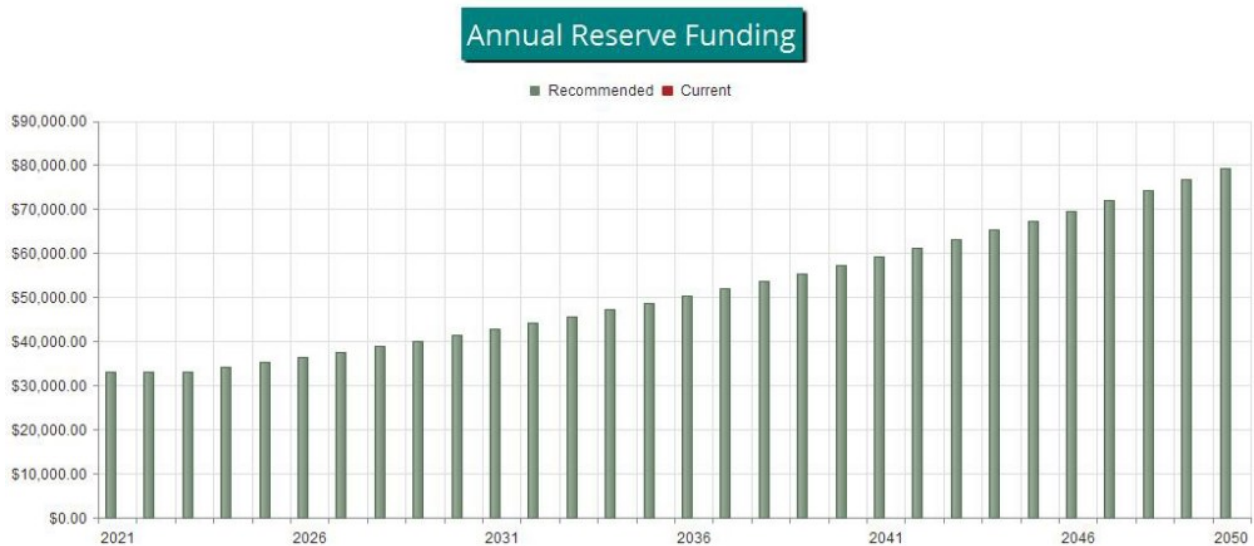
Figure 2

Based on your current Percent Funded and your near-term and long-term Reserve needs, we are recommending budgeted contributions of \$33,000/Annual this Fiscal Year. The overall 30-yr plan, in perspective, is shown below. This same information is shown numerically in both the 30-yr Summary and the Cash Flow Detail tables.

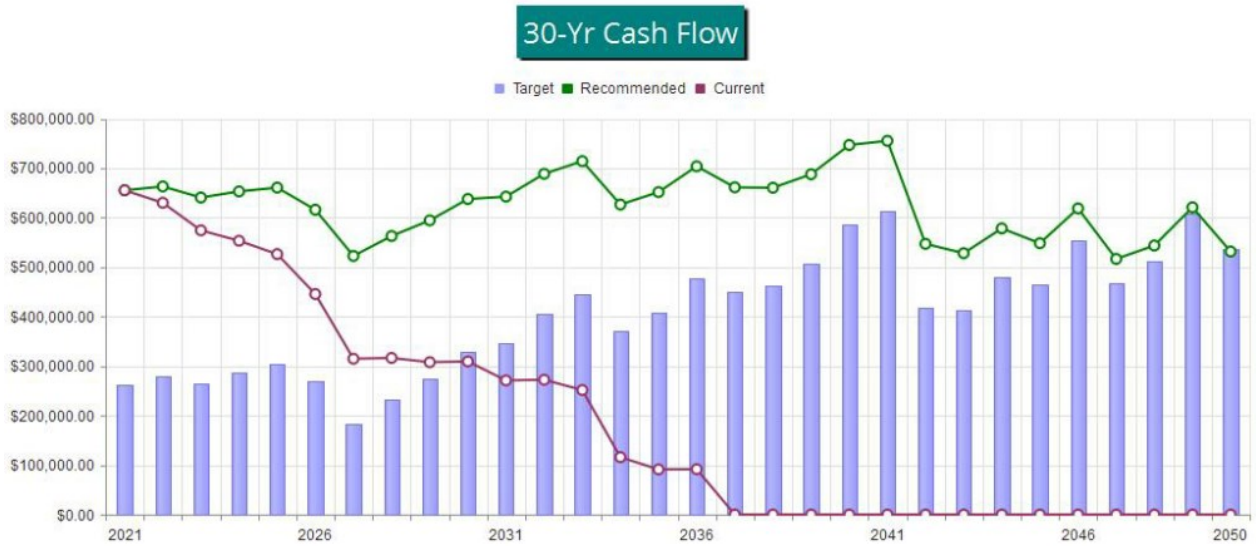
Figure 3

The following chart shows your Reserve balance under our recommended Full Funding Plan and at your current budgeted contribution rate, compared to your always-changing Fully Funded Balance target.

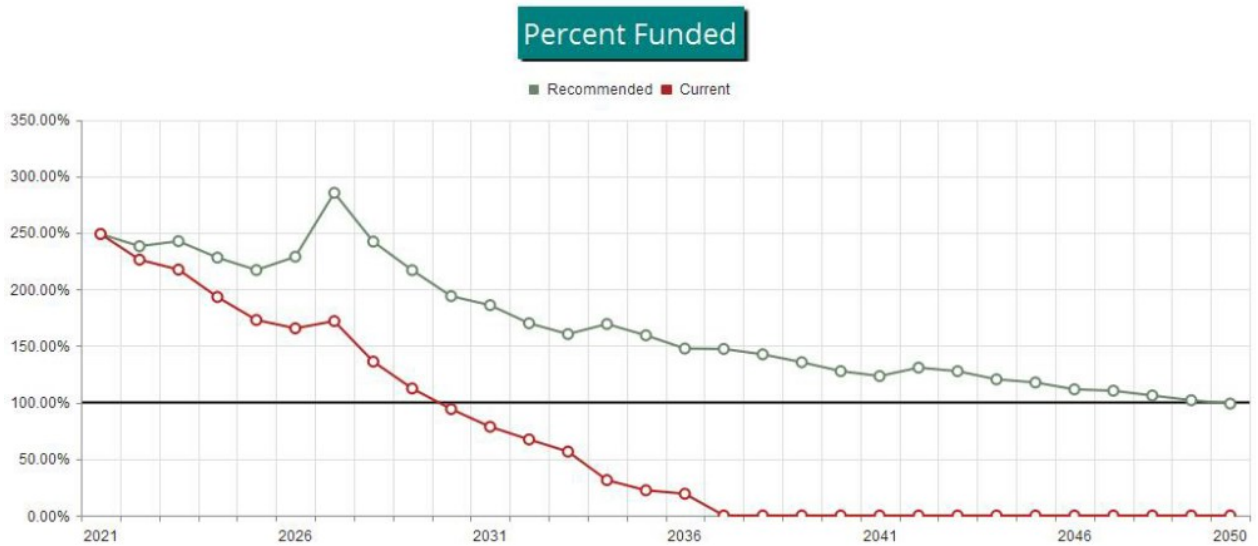
Figure 4

This figure shows the same information plotted on a Percent Funded scale. It is clear here to see how your Reserve Fund strength approaches the 100% Funded level under our recommended multi-yr Funding Plan.

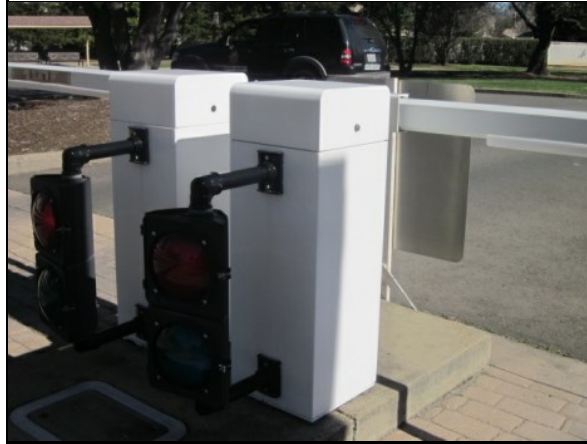
Comments: Functional condition noted with no functional/operational problems observed during our site inspection and no reported ongoing problems. Even with ongoing maintenance, plan for replacement at typical life expectancy indicated below. As routine maintenance, we recommend regular professional inspections including service and repair as needed from the operating budget.

Useful Life:
10 years

Remaining Life:
1 years

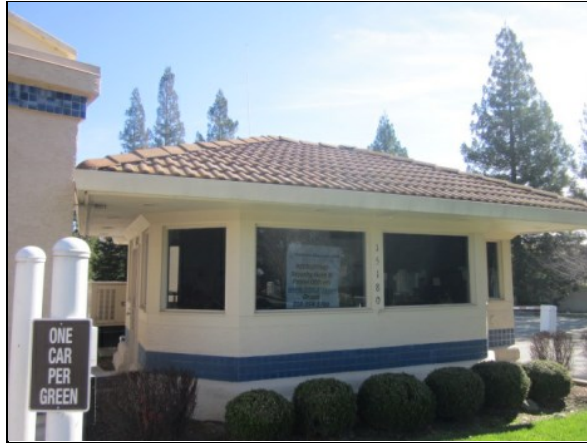
Comp #: 30206 South Gate Sec. Bldg. - Repair

Comments: South gate security building is a stucco building with tile roof. Currently in good condition. No expectation to replace this building. This component provides funding to replace the tile roof underlayment, replace broken tiles, provide repairs to the stucco, door and other physical repairs or upgrades to the building as needed.

Useful Life:
30 years

Remaining Life:
5 years

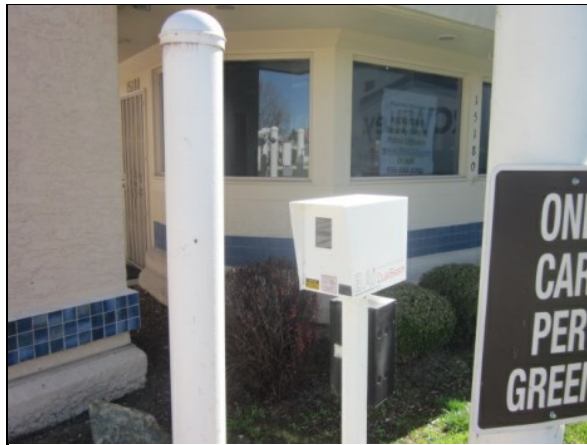
Comments: New and functional condition. No issues at this time. Due to technology innovation, anticipate the need for future replacement.

Useful Life:
7 years

Remaining Life:
5 years

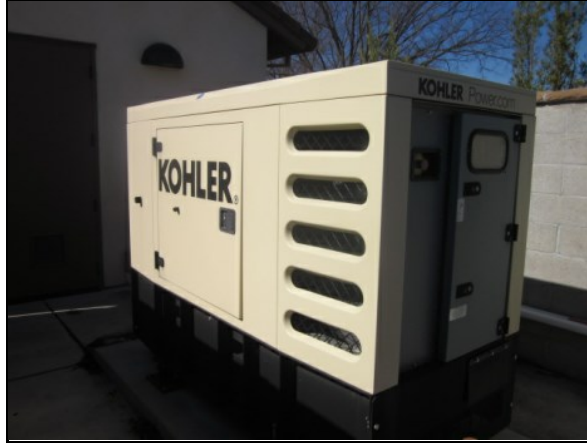
Comp #: 30301 Generator - Replace (North)

Comments: Fair, functional condition. Diesel 40Kw. Vendors typically report that with ongoing maintenance (e.g. fluids, batteries, tune ups), useful life can be extended for many years, sometimes 40-50 years. However, funding for complete replacement is often warranted due to lack of available replacement parts rather than failure of the system as a whole. Treat periodic service and inspect as general maintenance expense within Operating budget, not Reserves. Generator is a key building element in this location due to risk of severe storms and power outages, and should be tested and evaluated regularly to ensure proper function.

Useful Life:
40 years

Remaining Life:
35 years

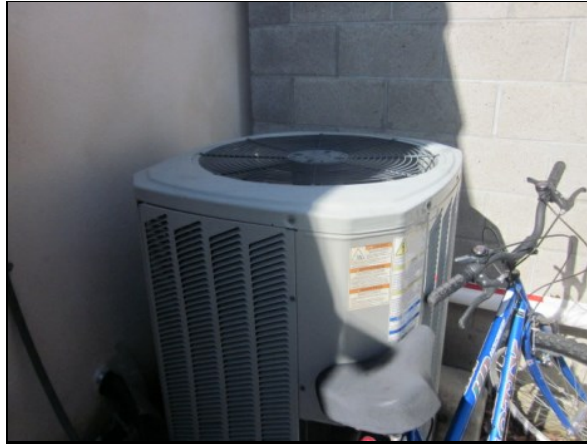
Comp #: 30302 HVAC (North Gate) - Replace

Comments: With proactive service and maintenance, useful life can often be extended - have service vendor evaluate continuously and adjust useful life/remaining useful life as indicated within reserve study updates. As routine maintenance, regular professional inspections and maintenance will help to extend useful life cycles and achieve lowest annualized costs. Treat local repairs as a general operating and maintenance expense. Funding below is for future full replacement.

Useful Life:
20 years

Remaining Life:
15 years

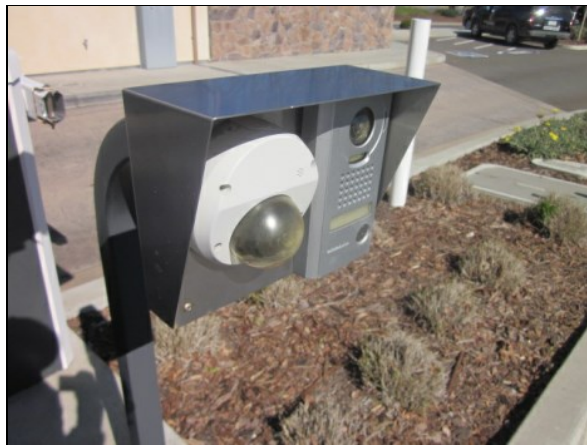
Comp #: 30303 Intercoms (North) - Replace

Comments: Intercoms are in good condition and functional. Located in an unprotected location exposed to the elements. There are normal signs of wear evident including scratches, scuffs and fading. No premature wear or abuse detected. Fund at the interval below for future replacement.

Useful Life:
18 years

Remaining Life:
13 years

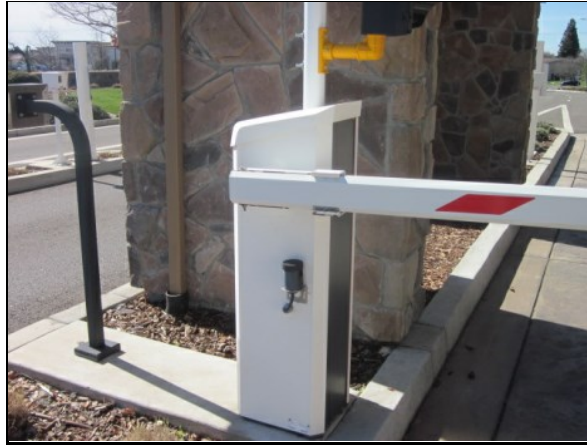
Comp #: 30304 Gate Operator (North) - Replace

Comments: Gate operators are in good condition, intact and functional. Even with ongoing maintenance, plan for replacement at typical life expectancy indicated below. As routine maintenance, we recommend regular professional inspections including service and repair as needed from the operating budget.

Useful Life:
10 years

Remaining Life:
5 years

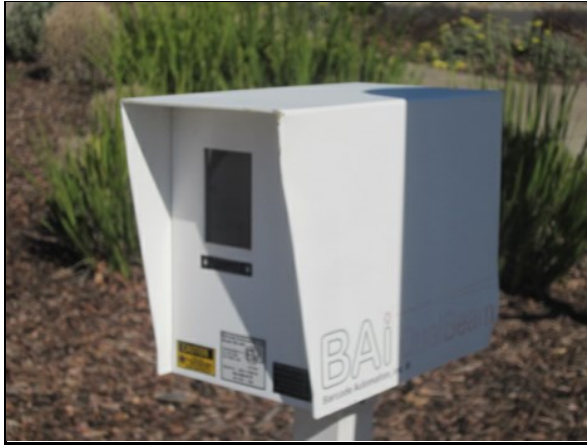
Comp #: 30306 Barcode Reader (North) - Replace

Comments: Functional condition. No issues at this time. Due to technology innovation, anticipate the need for future replacement.

Useful Life:
7 years

Remaining Life:
2 years
